**N1913A-03A**

**S E R V I C E N O T E**

**N1913A EPM Series Single-Channel Power Meter**

**Lack of Front Sensor Input for N1913A–Option 108**

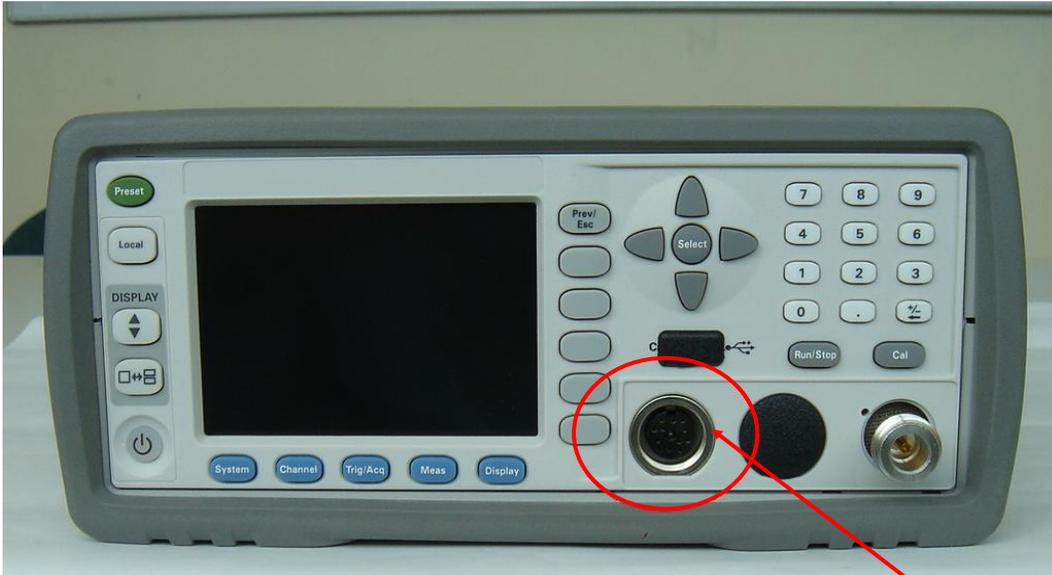
Figure 2

Sensor inputs are available in rear and front panel now

1. Customer can contact Agilent's Customer Contact Center (CCC) for returning the unit to Agilent's Service Center for a factory rework.
2. CCC will arrange with Agilent's Customer Service Representative (CSR) for sending the prepaid shipping label to customer for a no-charge return to the Agilent Service Center
3. Figure 1 and figure 2 show the physical condition of the N1913A option 108 after install of the front sensor input. The sensor inputs are installed at front and rear panel of N1913A.
