N4010A-01

S E R V I C E N O T E

N4010A Wireless Connectivity Test Set

Customers may find the fan noise produced by the N4010A unacceptable

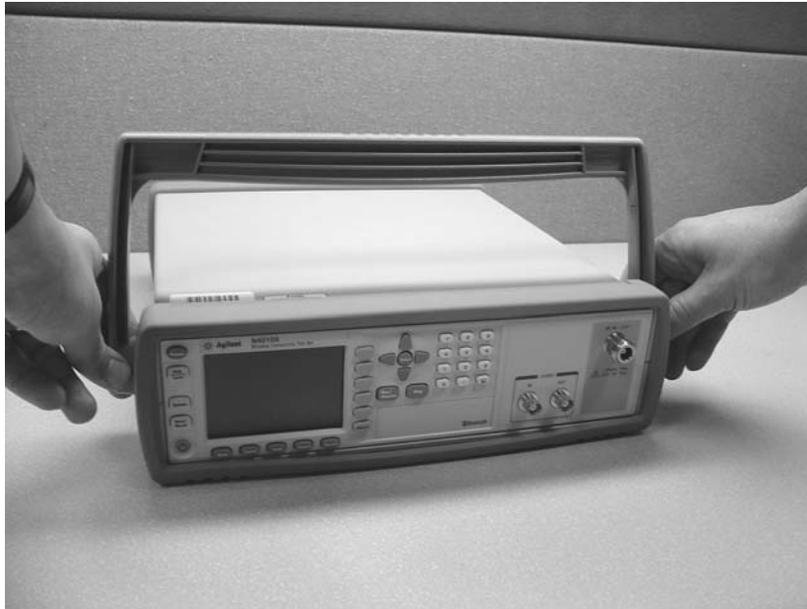
Disconnect the power cord from the instrument and remove the handle as shown.

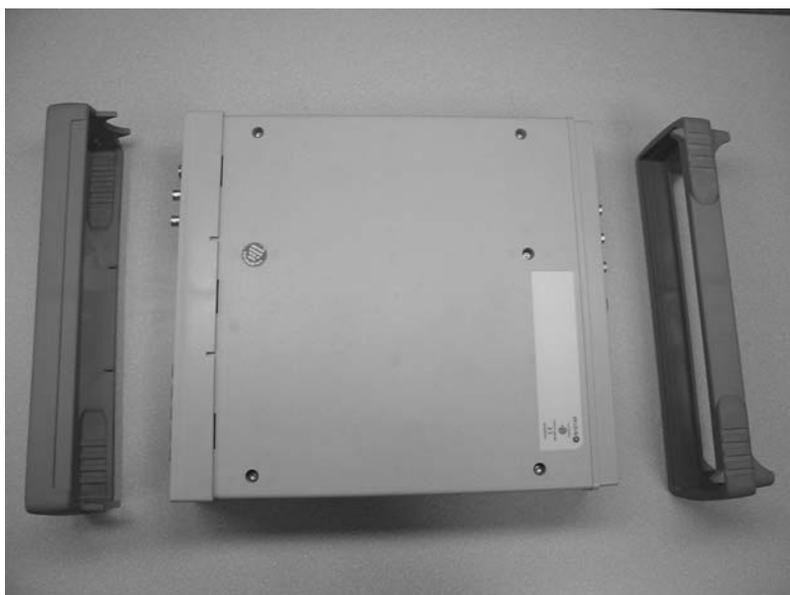
Place the instrument on its topside and pull off the front and rear bumpers as shown

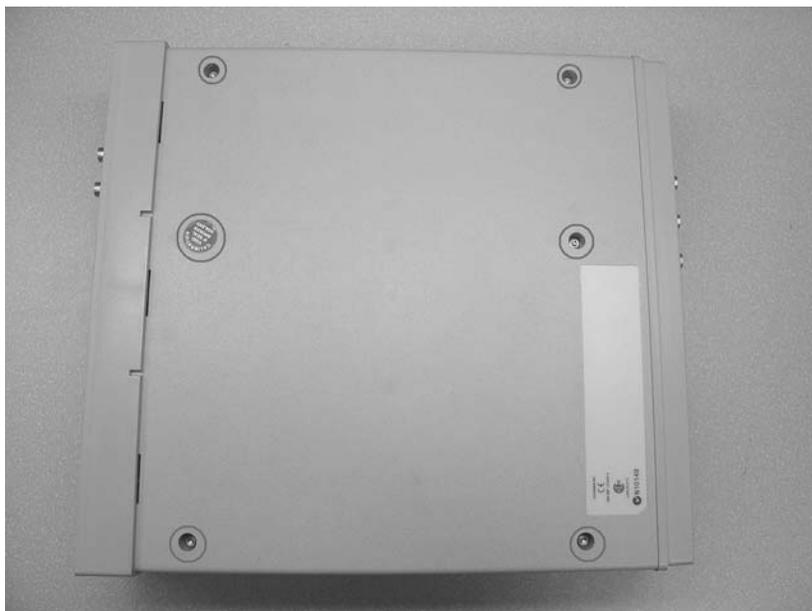
Undo the six screws as shown.

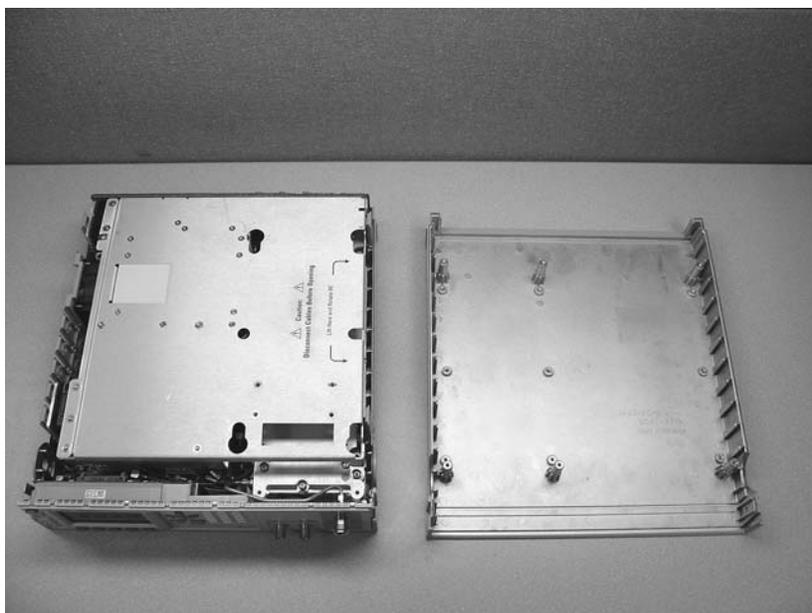
Turn the instrument over and lift off the top clamshell cover.

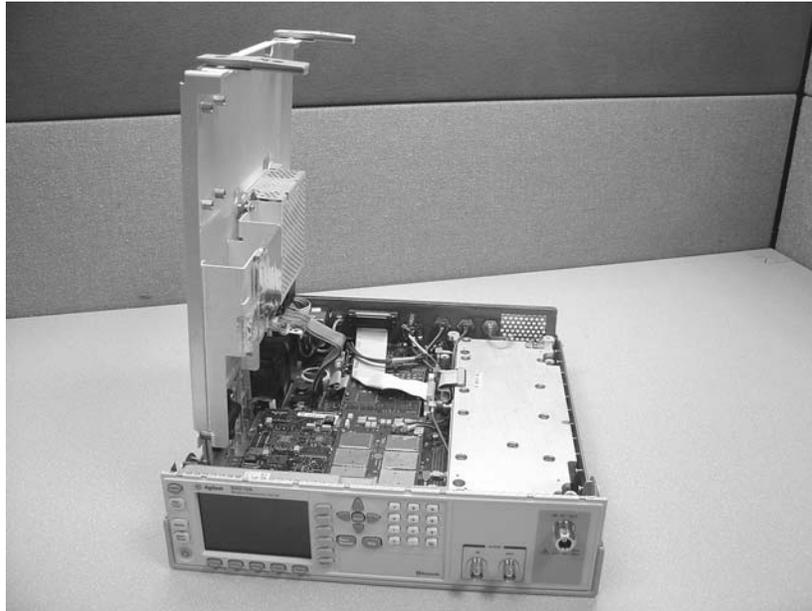
The inner cover is hinged and should be rotated to the position shown.

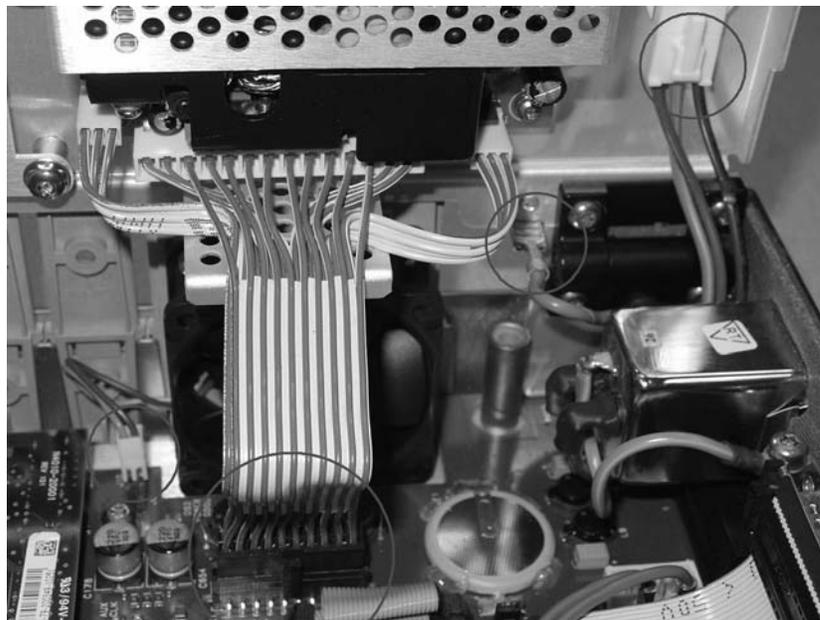
Disconnect the four connections shown.

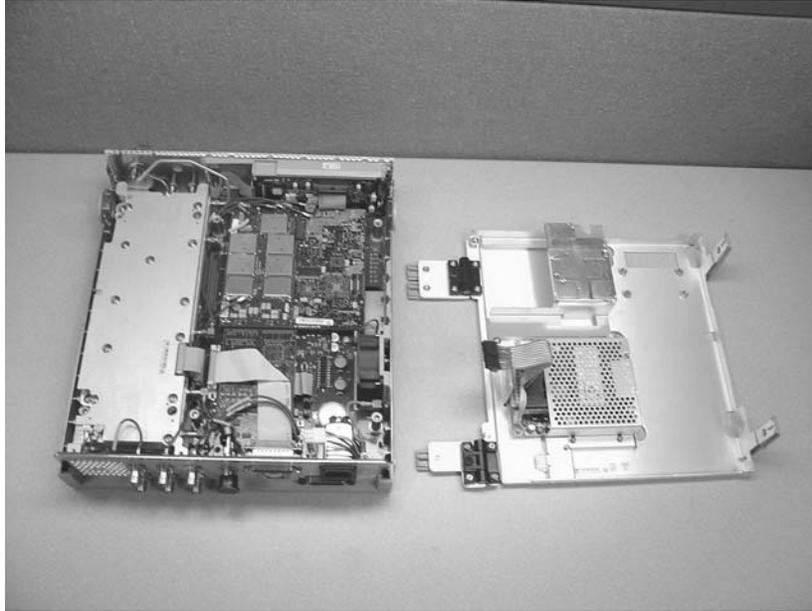
Remove the inner cover by pulling it upwards away from the main deck.

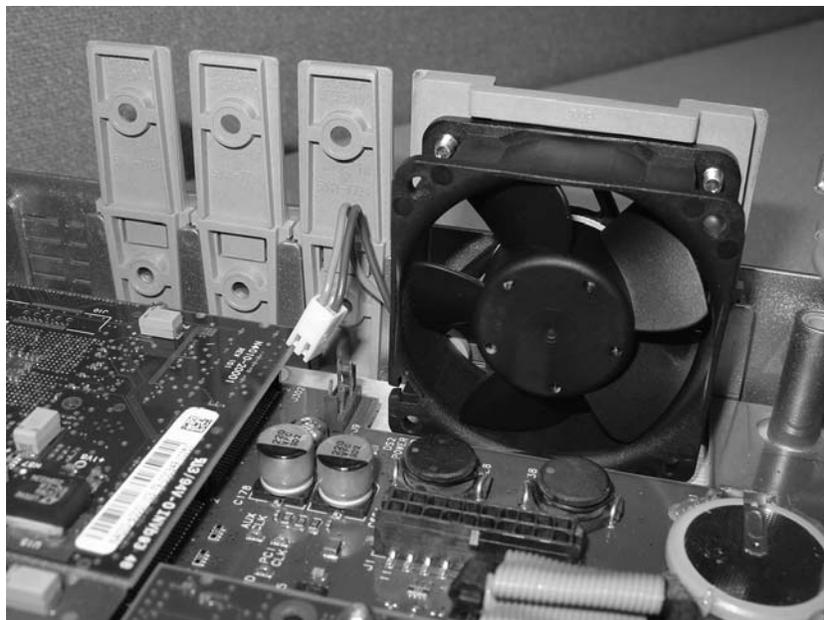
The instrument fan is now accessible. Remove the fan and the three filler plates by pulling them upwards away from the main deck.

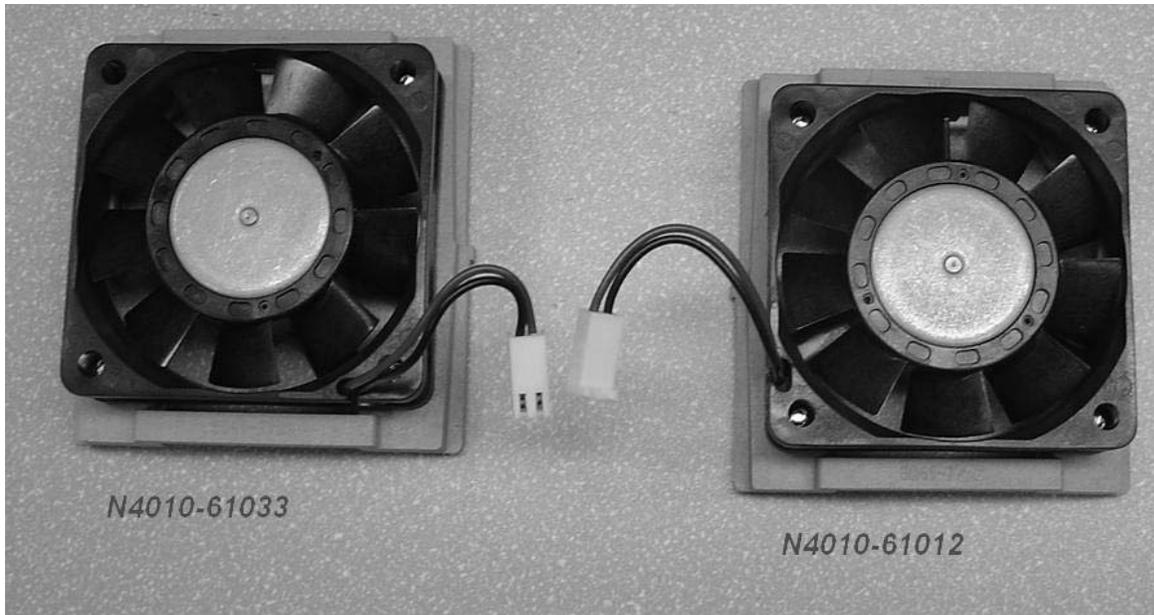
The instrument fan is replaced by N4010-61012. A second fan, N4010-61033, is added where the filler plates were removed. The two fans are shown below

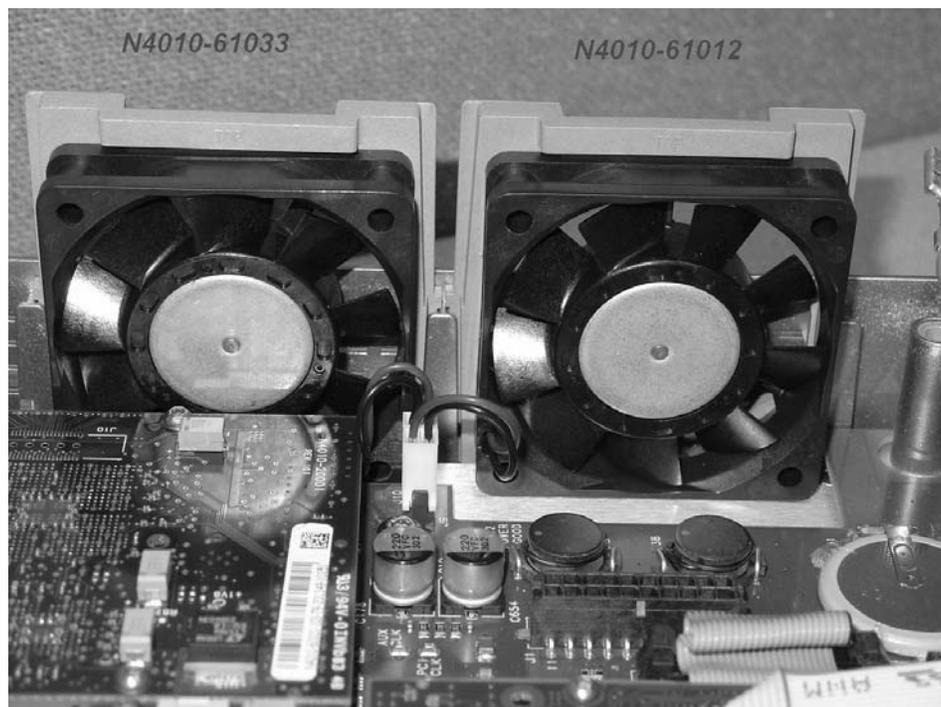
The new fans shown fitted in the main deck. Connect N4010-61012 to connector J9 and N4010-61033 to connector J10.
