N4903A-01A-S

S E R V I C E N O T E

N4903A, High-Performance Serial BERT

POSSIBLE FIRE HAZARD

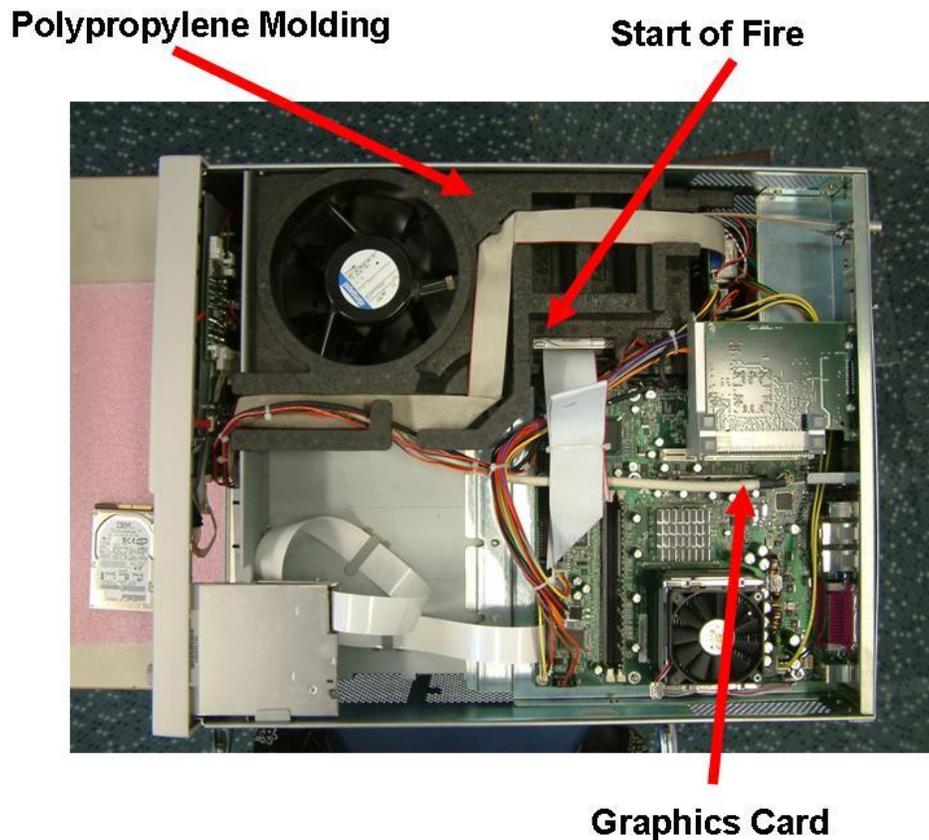
A surface-mount ceramic capacitor suffered physical stress during the manufacturing process, leading the capacitor to crack. During operation this crack placed stress on the internal structure of the capacitor, and caused the plates to short together. (The plates are separated by very little space, made up of very thin insulators.) This caused the capacitor to have very low residual impedance, resulting in a very high current conducted through the capacitor and the 12V path on the motherboard for some period of time. The low impedance didn't lead to a current high enough for blowing the fuse. Therefore the higher current was available long enough to create a very high temperature ($T > 300^{\circ}\text{C}$) The high temperature ignited the polyurethane molding used to conduct the airflow for cooling through the instrument.

The following photo illustrates the layout of the instrument. It shows the polypropylene molding, the graphics card and the starting point of the fire.

The countermeasure for this issue is to exchange the graphics cards. The new graphics cards are produced with an improved manufacturing process eliminating the risk of micro cracks. They either have an additional fusing to protect the 12V path or they have eliminated the 12V path altogether. The graphics card can be exchanged by Agilent authorized personnel only.

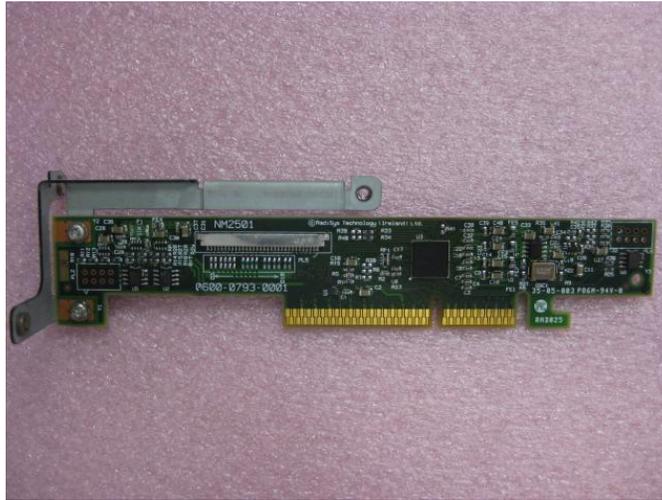
The concerned part is the graphic board: N4901-66577 (exchange part: N4901-69577):

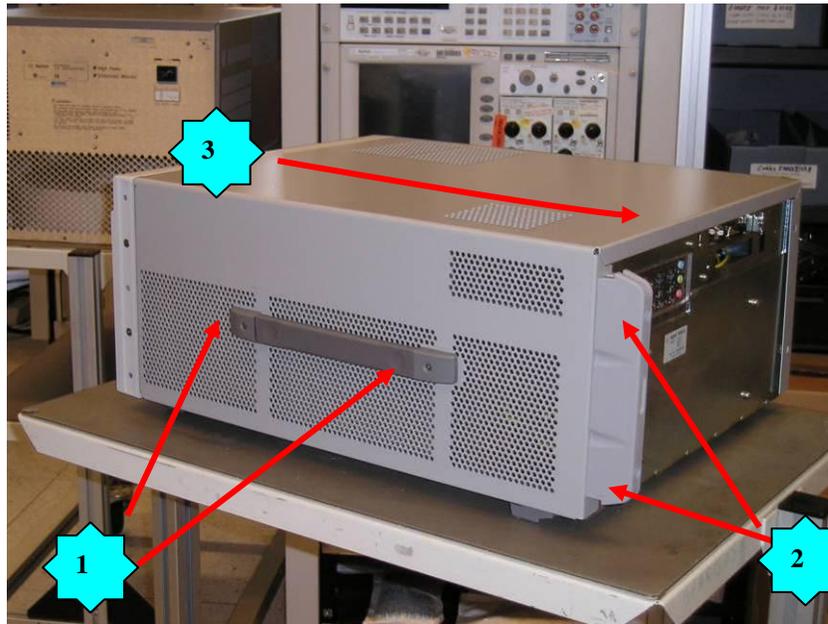
1. Open unit

- Remove the carrying handles from each side of the case by removing two screws (Torx 20) each.
- Remove the rear feet by removing two screws (Torx 15) each
- Remove the top cover by slightly lifting it up the back and then pulling it backwards until the cover comes free of the front frame slots.

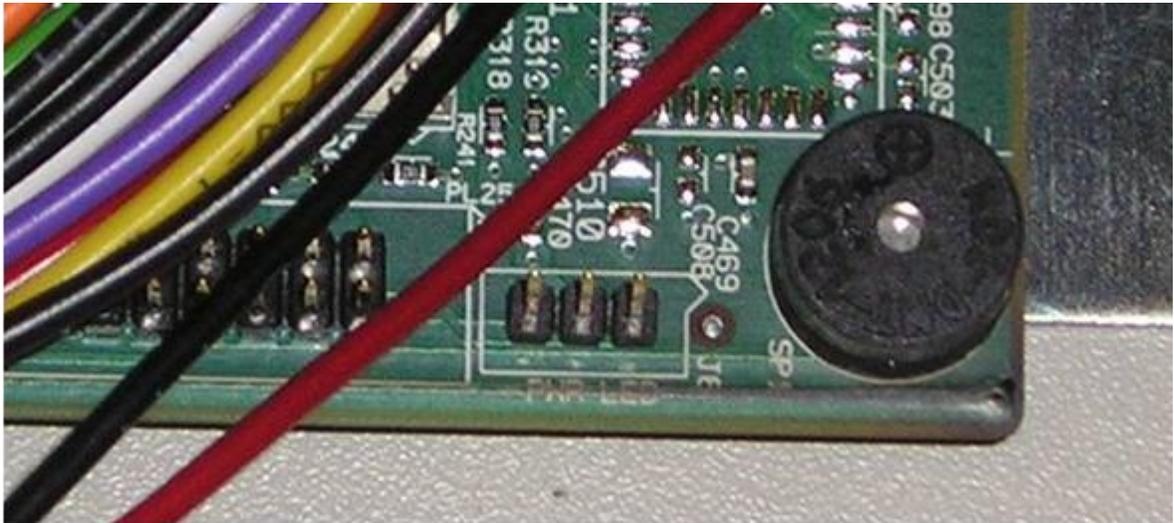
3. Important: Check potential motherboard discoloring

There might be discoloring on the PC motherboard in the shown corner (brown color). This can be ignored. The function or the quality of the motherboard is not affected by this.

Motherboard still considered being good – no exchange required:

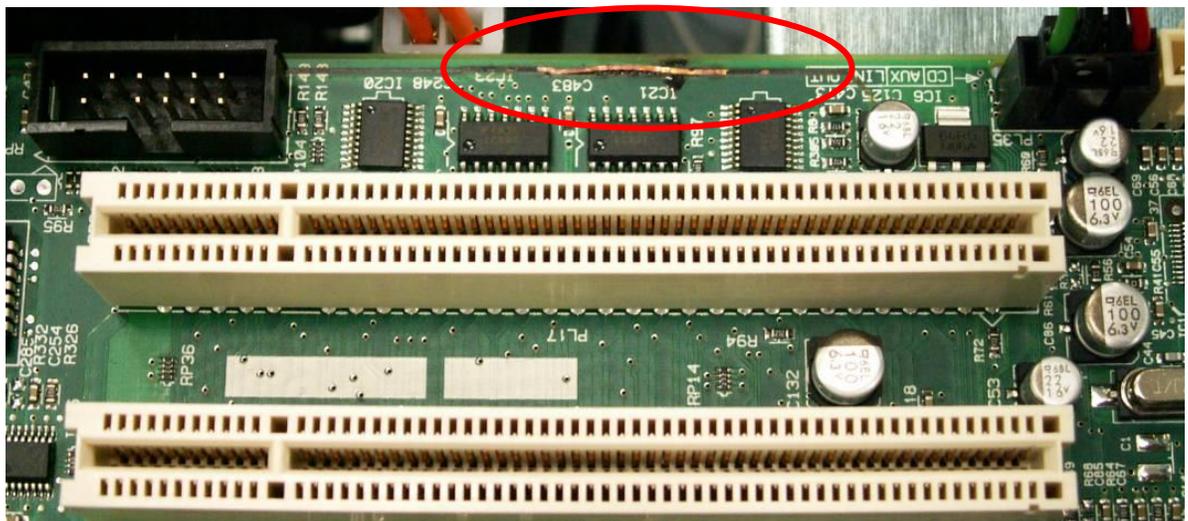
In very exceptional cases if you see traces of smoke or fire, the motherboard needs to be exchanged. In these cases typically the integrated display of the instrument would not work anymore. The exchange of the motherboards can only be done in the Service Center - onsite repair is not possible.

Motherboard considered being bad – please exchange:

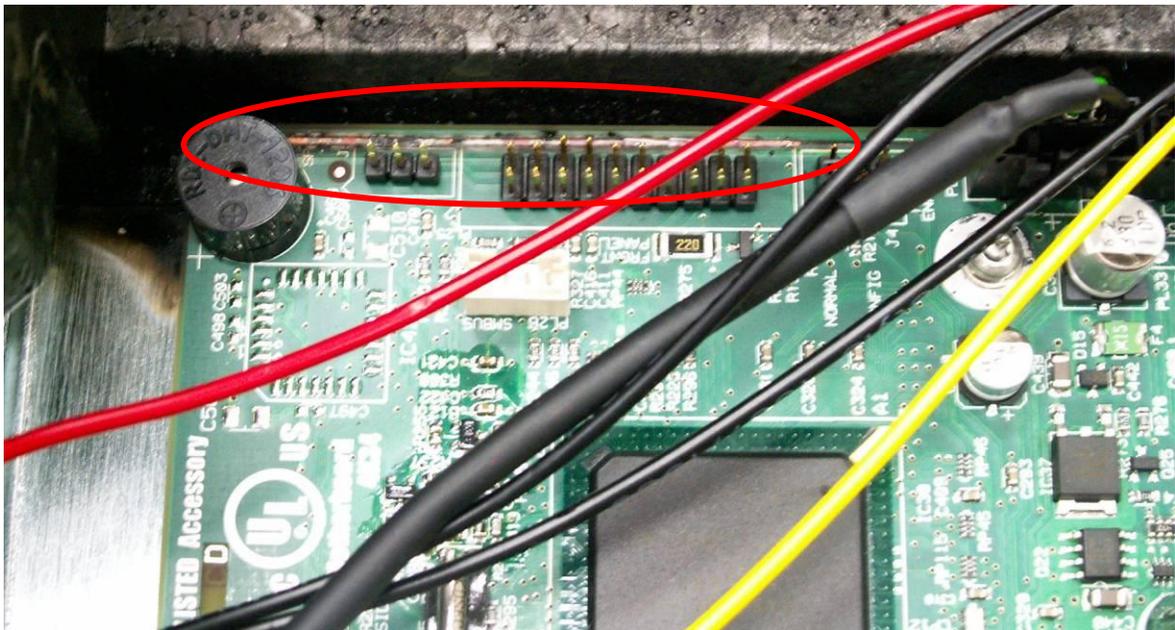
Motherboard considered being bad – please exchange:

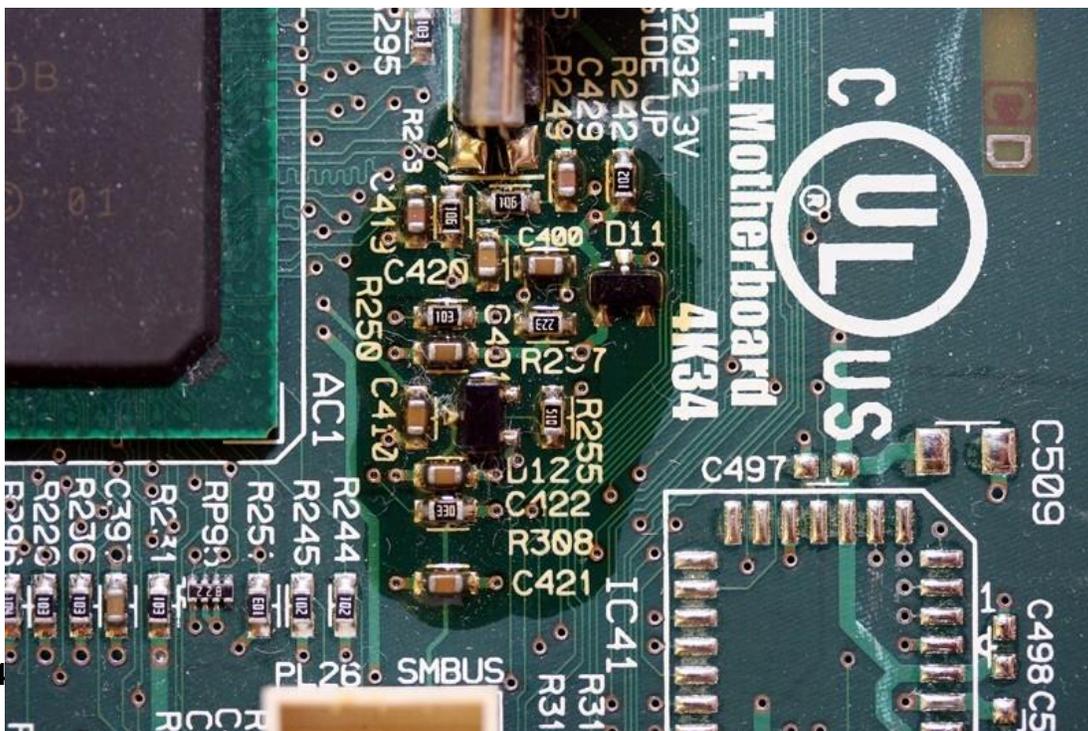
The following discoloring is intentional – no exchange required:

This effect is caused by an intentional sealing of a high impedance area to avoid issues in environments with a high degree of humidity. No exchange of the motherboard is required here.

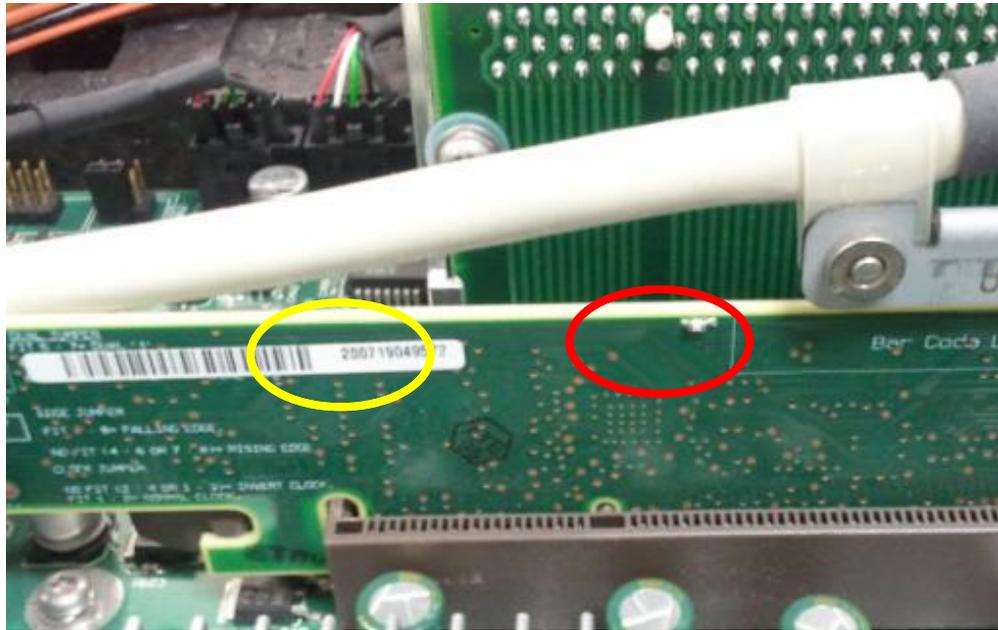
- Sample #1 (Revision NM2501):

The board has a fuse on top (red circle) and a serial number (yellow circle) starting with 200... In the case above it is 200719049572)

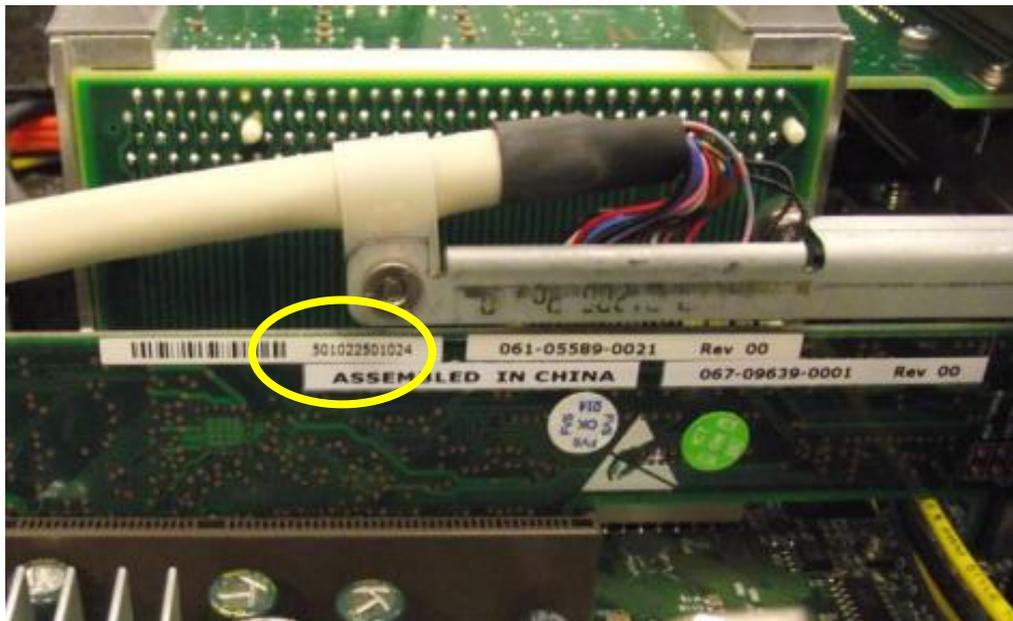
- Sample #2 (Revision NM2502):

The board has a serial number (yellow circle) **NOT** starting with 200... In the case above it is: 501022501024.

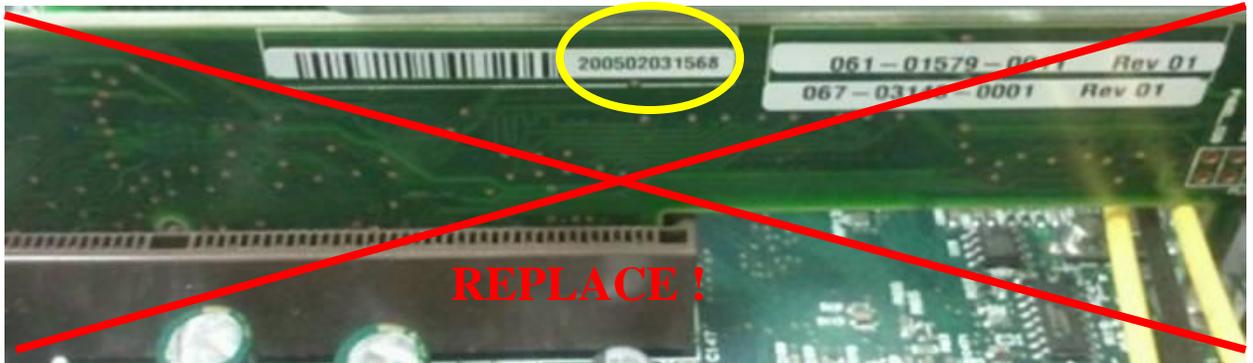
If the graphic board

shows a serial number starting with 200... AND no fuse is visible

it is potentially **hazardous** and the **unit must be set out of operation** until the graphic board is replaced (part number: N4901-66577 or N4901-69577). The graphic board can be exchanged without impacting the instrument's performance.
