N4903B-02

N4903B - Serial Bit Error Ratio Tester with Option J20

Front plate has incorrect physical dimensions (wrong thickness)

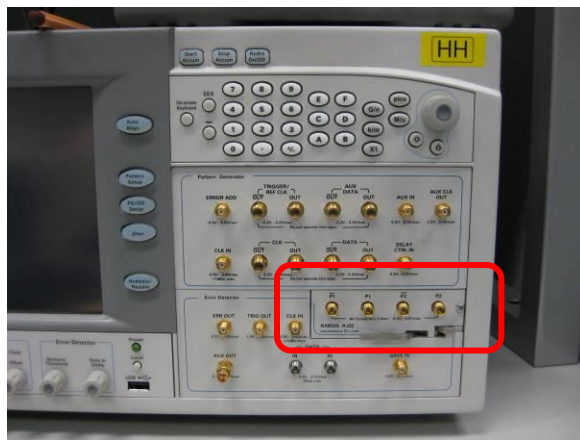
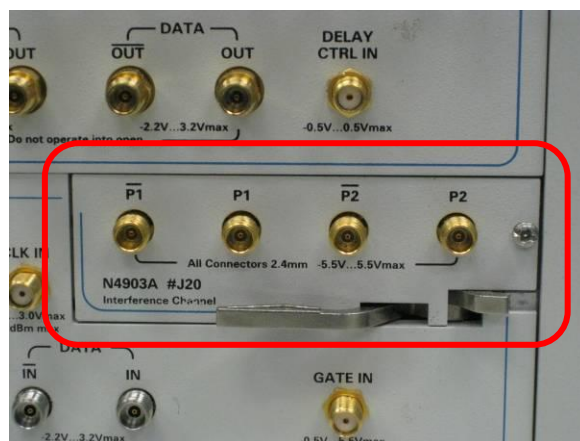
The N4903B Option J20 is a plug-in module that inserts into a N4903B or N4903A product as shown in the next 2 pictures

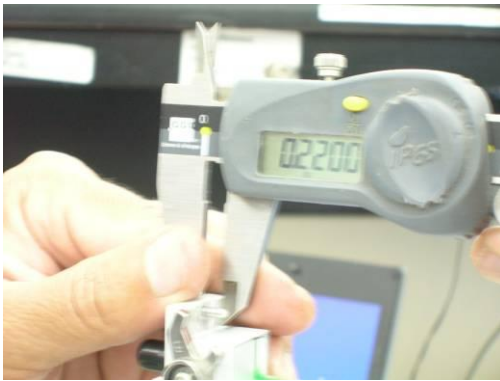
This issue with the old front plate is the following:

The thickness / width of the front plate should be 5.2mm (0.20in) and not 5.7mm (0.22in) as shown in the picture above.
