**N5181A-03**

## N5181A MXG Analog Signal Generator

**“Batch related power supply issue may result in a non-functioning instrument”**

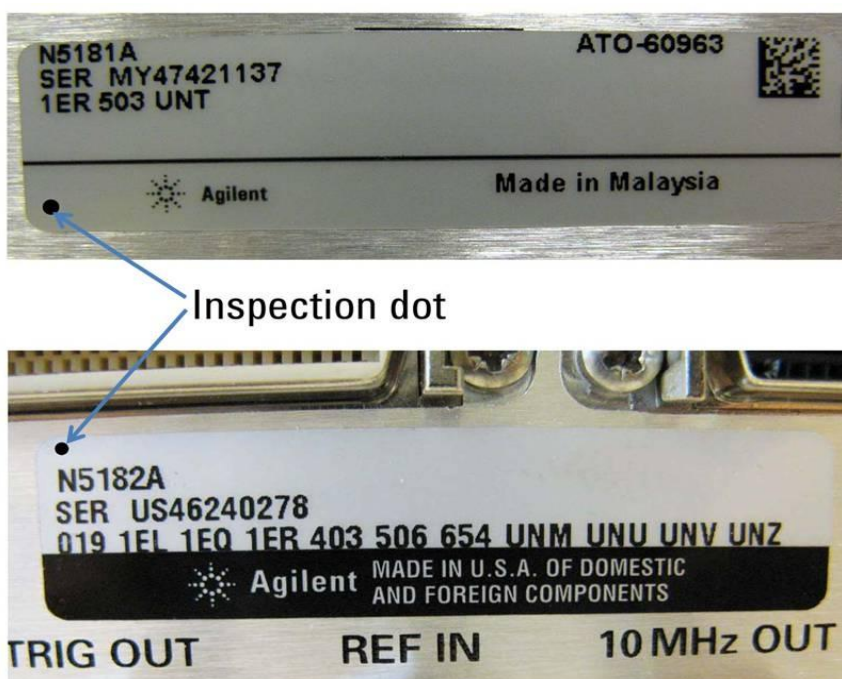
1. For a suspected N5181A, check the rear panel serial tag for a small black inspection dot (see images below). If a black dot is present, similar to what is depicted, the instrument has been checked or previously repaired and no further action is required
2. If the dot is missing proceed to step 3.

10. Using a permanent marker, place a black dot on the serial tag as depicted in step 1. Doing so will assist in future quick recognition that a specific unit has been inspected or repaired.
11. The instrument is now ready for use.

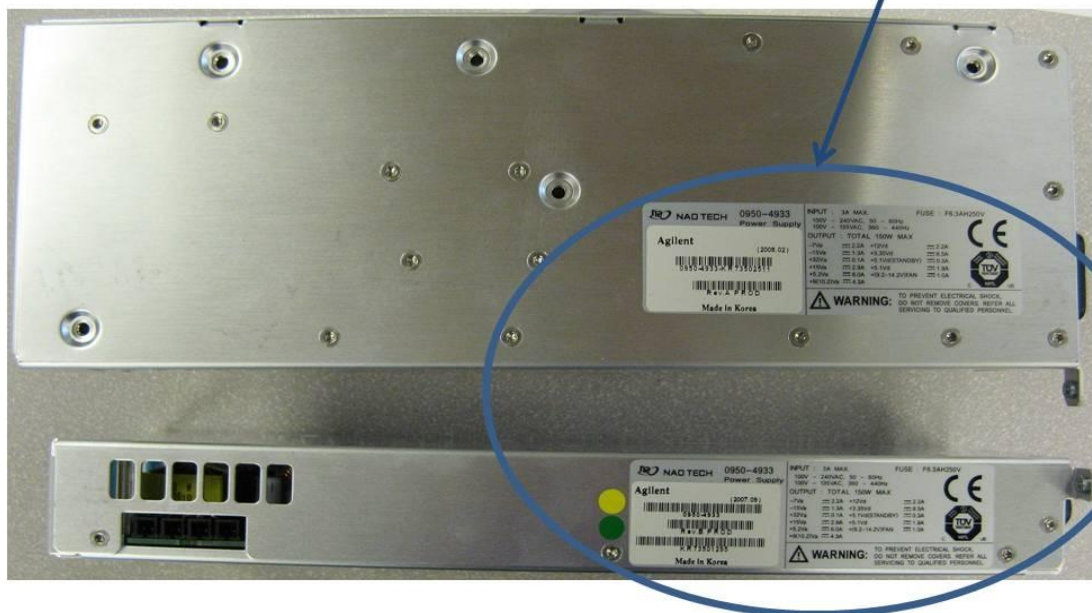
## Identification label locations

3. Remove the external and then the internal top cover; using the instructions in the MXG Service Guide.
4. Check the A1 power supply serial number. (See images below for location and examples). The power supply identification label can be located on either the top or sides of the power supply.

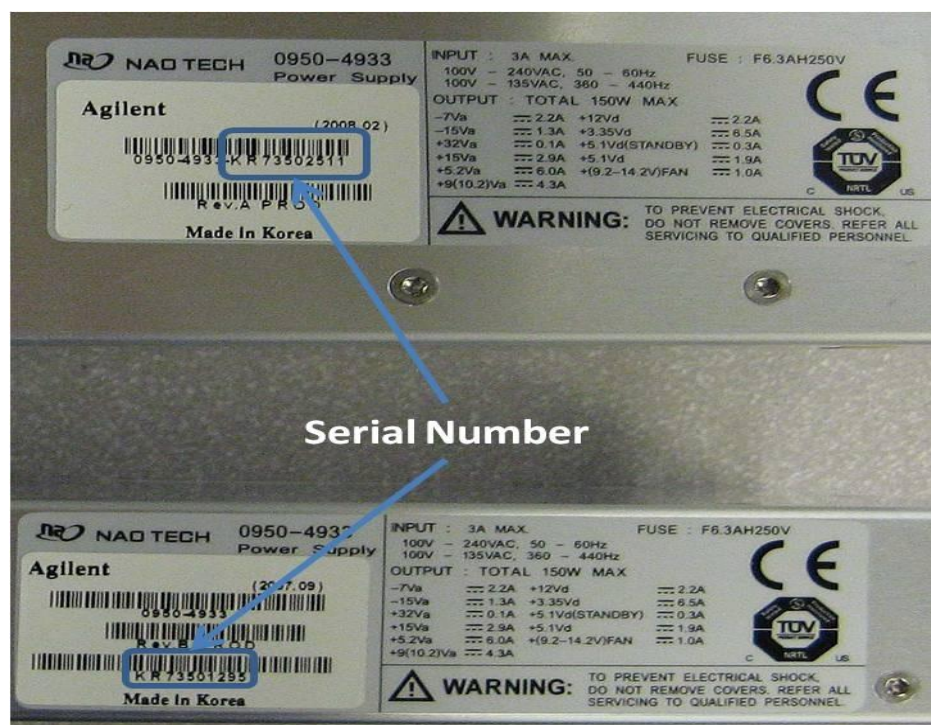
## Examples:

The serial numbers below are the 10 alpha-numeric digits on the identification label. In the following examples the formatting is different between identification labels. The serial numbers depicted are KR73502511 and KR73501295.

5. If the suspected A1 power supply serial number does not match one of the suspected power supply serial numbers listed below, go to step 7. If the serial number is on the list, continue to step 6.
