N9000B-01-S

Safety Service Note

N9000B CXA Signal Analyzer

POSSIBLE DROP HAZARD

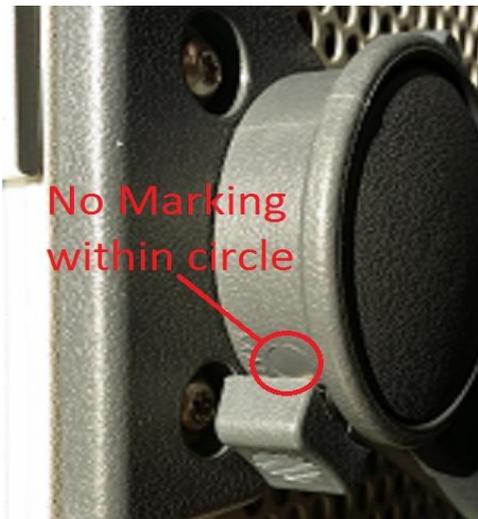
Replace the bail handle assembly with a known-good assembly. Figure 1 shows a close-up of the area around the hub of the bail handle assembly, near one of the buttons to rotate the handle. Look for the button that has “MADE IN USA” embossed near it. Note the circular feature in the bail handle. If there is no mark inside the circle, the bail handle assembly is an early production unit and must be replaced and destroyed to prevent it from being used again.

Figure 1. Circle with no markings. This handle should be replaced.

To replace the bail handle assembly, follow the instructions included in the Bail Handle Replacement Kit.

Any bail handle assembly replaced should be destroyed to prevent it from being used again. To destroy a handle, it is recommended that it be cut in half using a hacksaw, bandsaw, or similar tool.

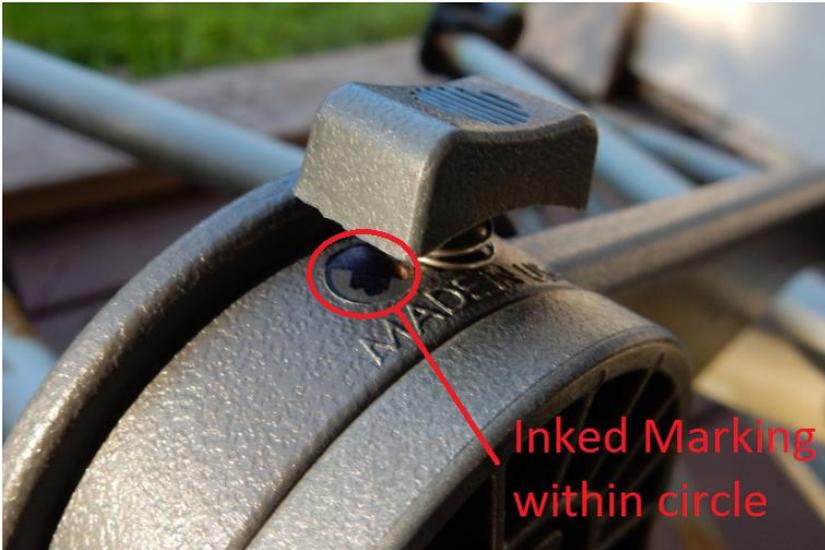
Figures 2 and 3 also show a close-up of the area around the hub of the bail handle assembly of later production units. Note the ink marking or an embossed ridge through the center of the circle.

Figure 2. Circle with inked marking. This handle is OK.

Check near the button that has “MADE IN USA” embossed near it for either an ink or embossed ridge mark. If you see one of these marks, the bail handle assembly is OK and does not need to be replaced.

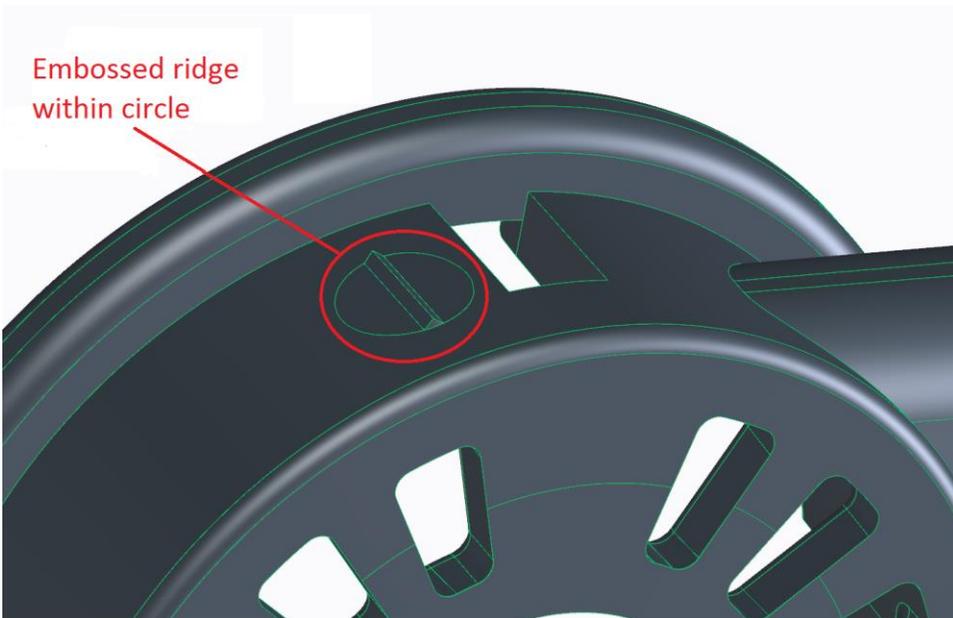
Figure 3. Circle with embossed ridge marking. This handle is OK.
