N9020B-01-S

Safety Service Note

N9020B MXA Signal Analyzer

POSSIBLE DROP HAZARD

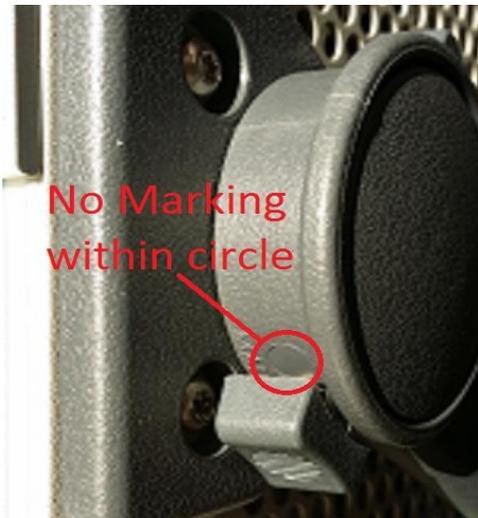
Replace the bail handle assembly with a known-good assembly. Figure 1 shows a close-up of the area around the hub of the bail handle assembly, near one of the buttons to rotate the handle. Look for the button that has “MADE IN USA” embossed near it. Note the circular feature in the bail handle. If there is no mark inside the circle, the bail handle assembly is an early production unit and must be replaced and destroyed to prevent it from being used again.

Figure 1. Circle with no markings. This handle should be replaced.

To replace the bail handle assembly, follow the instructions included in the Bail Handle Replacement Kit.

Any bail handle assembly replaced should be destroyed to prevent it from being used again. To destroy a handle, it is recommended that it be cut in half using a hacksaw, bandsaw, or similar tool.
