Qualitative Assessment on the Effects of Damaged Connectors and Optical Interfaces in Fiber Optic Measurements

White Paper

Presented by Peter Linowitz
Agilent Technologies
National Conference of Standards Laboratories (NCSL)

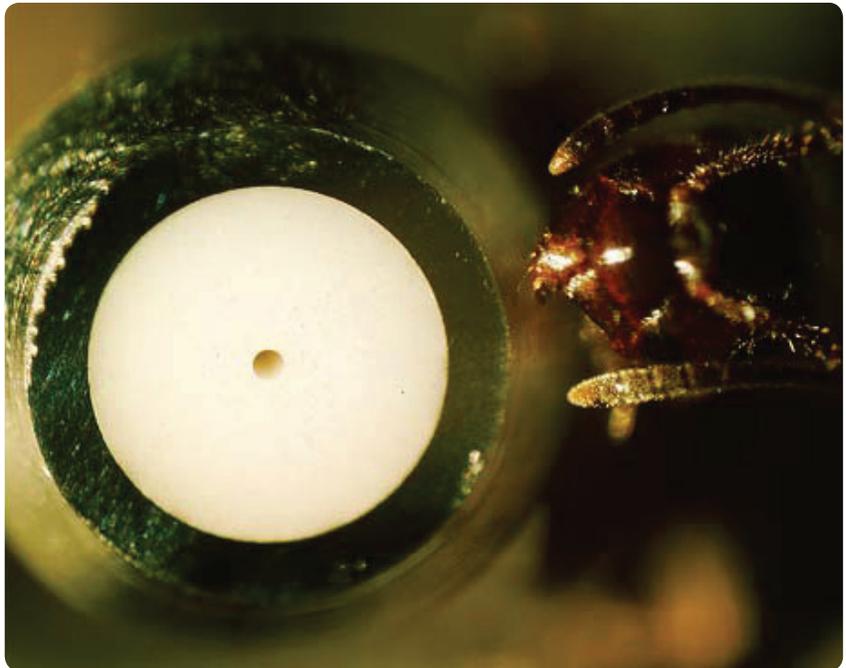
Feel of Dimensions ... (4)

- Same scale as previous slide.
- This time FC/PC and head of an ant.
- The center circle inside the white area is $125\ \mu\text{m}$!
- The core itself is only a fraction of it, $9\ \mu\text{m}$. Seen as the red dot in the center

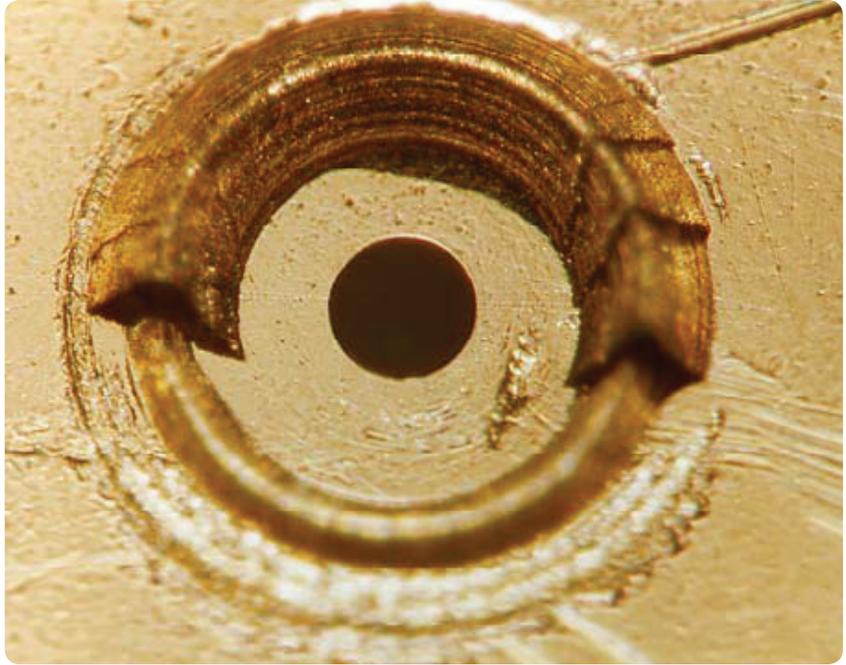
HMS-10

Good fiber in connector.

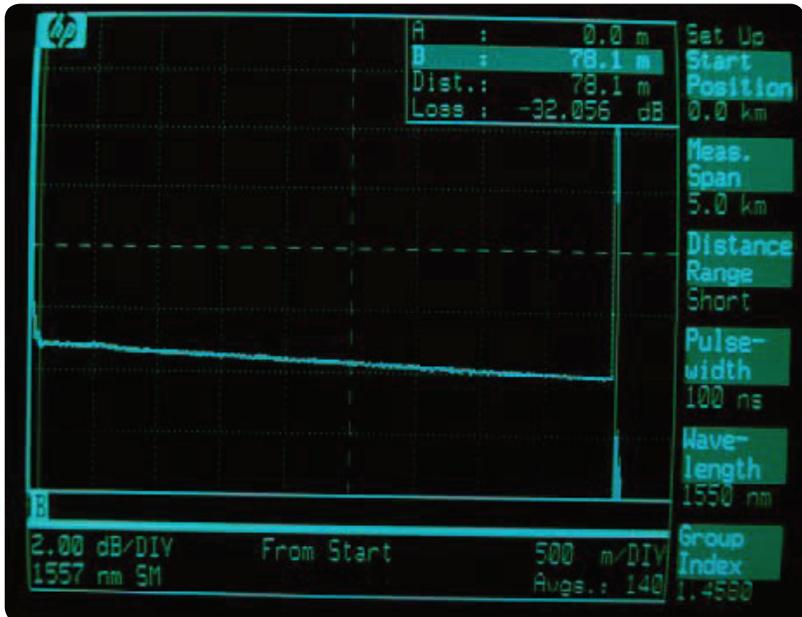
OTDR Trace

Good trace of 4.5 km delay line

Note good launch into a good fiber, i.e. minimum backreflection at connector interface

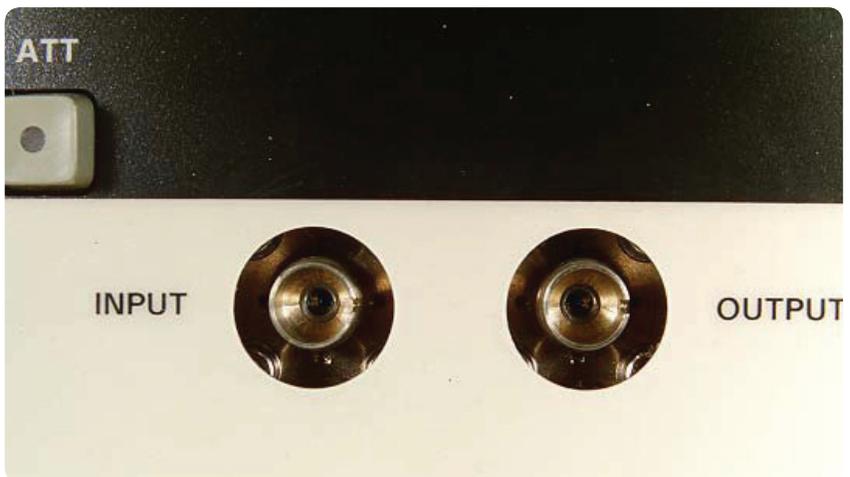
Optical Interfaces

Front panel

Note collimating lenses (bluish color)

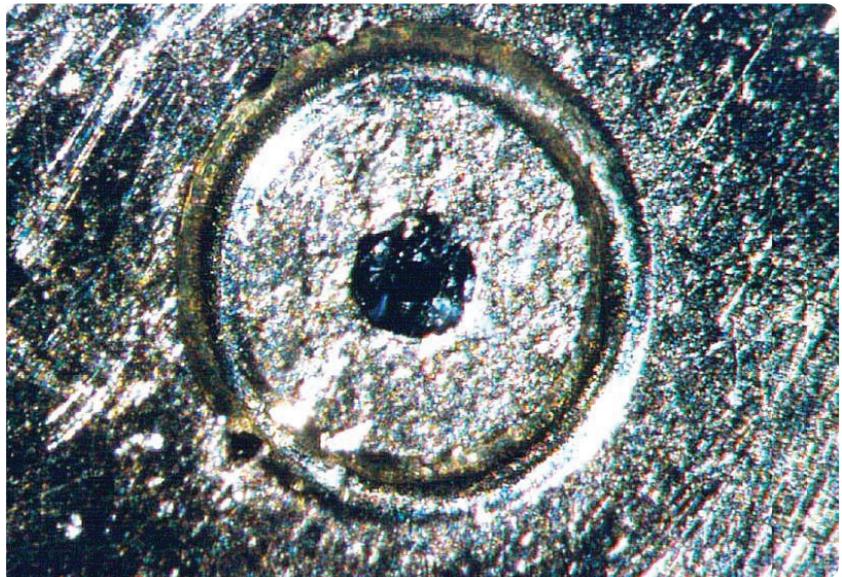
OSA Input Connector

Multimode fiber with 62.5 μm core and 125 μm cladding diameter (black and dark blue, respectively).
