**E4418B-17A**

**S E R V I C E N O T E**

**Agilent E4418B EPM Average Power Meter**

**Front Panel Display Problems Caused by Power Assembly Cable**

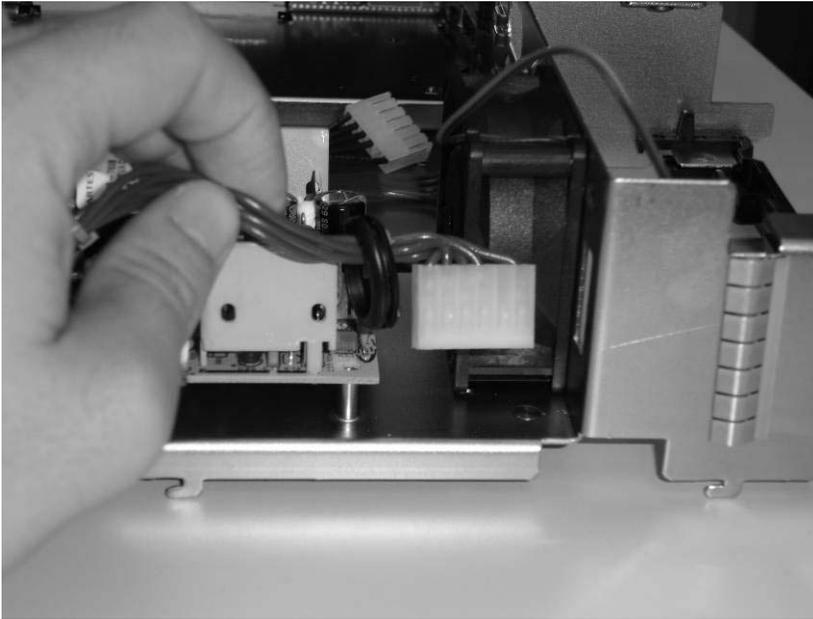
7) Photo below show different of old and new cable. The new cable is red in color whereas the old cable is black in color. The E4418-61005 has 1 ground wire.

- 3) Remove fan connector and PSU cable assembly and replace with new PSU cable assembly E4418-61005. You can differentiate the cable assembly by the colors. The old cable is Black and new cable is RED.
