N1996A-01

S E R V I C E N O T E

Agilent CSA Spectrum Analyzer, N1996A

Residual Responses due to Shield Problem on A4 Digital IF Assembly

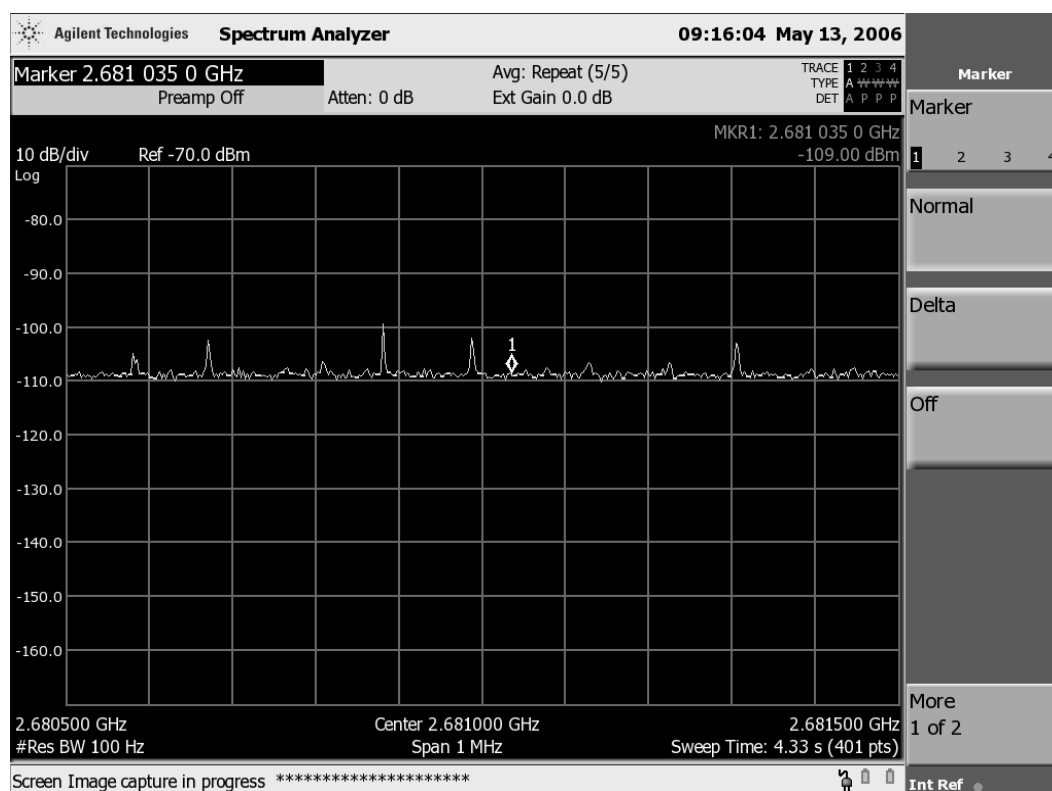
Figure 1: Marker Positioned on Average Noise Level

1. Terminate the analyzer input with a 50 Ohm load.
2. Press **Mode, Spectrum Analyzer**.
3. Press **Mode Preset**.
4. Press **FREQ, Center Freq, 2681 MHz**
5. Press **SPAN, 1 MHz**
6. Press **AMPTD, Ref Level, -70 dBm**.
7. Press **BW, Res BW, 100 Hz**.
8. Press **Meas Setup, Avg Mode, Repeat**
9. Press **Avg Number, 5, Enter**
10. Press **Trace/Detector, Average**
11. Press **Single**. Wait until the message “Paused. Press Continuous or Single to Continue” appears on the status line at the bottom of the display.
12. Press **Marker**. Use the knob to move the marker to a point which represents the average noise level, exclusive of any discrete responses, such as residual responses. See Figure 1.

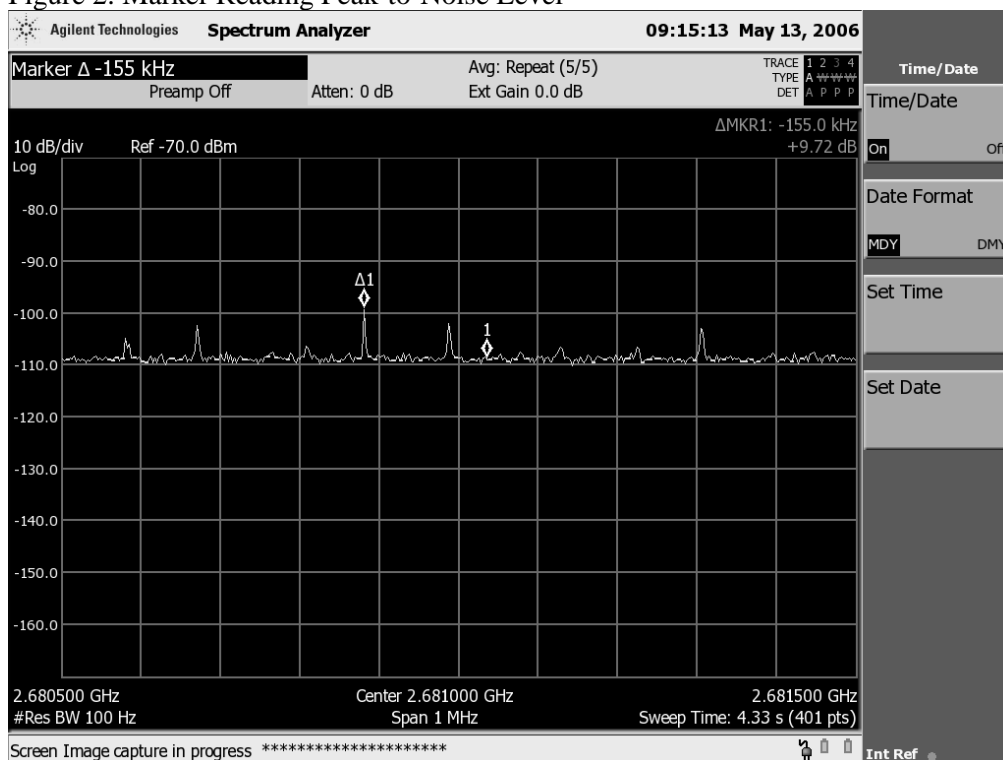
Figure 2: Marker Reading Peak-to-Noise Level

13. Record the marker amplitude value in Table 1 in the Noise Level column of the “As Received” row.
14. Press **Marker, Delta, Peak Search**. The marker amplitude reading now represents the difference between the noise level and the highest residual response. See Figure 2. Record this marker amplitude value in Table 1 in the Peak-to-Noise Level column of the “As Received” row.

15. Press **Marker, Normal**. The marker amplitude reading now represents the peak amplitude of the highest residual response. Record this marker amplitude value in Table 1 in the Peak Level column of the “As Received” row.
16. If the Peak-to-Noise Level is greater than 5 dB, the residual responses are too high. Proceed with Solution/Action.
17. If the Peak Level is above -98 dBm, the residual responses are too high. Proceed with Solution/Action.
18. If the Peak-to-Noise Level is less than 5 dB and the Peak Level is lower than -97.7 dBm, the level of the residuals is OK and no further action is required.
