**N1996A-01B**

Supersedes:  
N1996A-01A

## Agilent CSA Spectrum Analyzer, N1996A

### Residual Responses due to Shield Problem on A4 Digital IF Assembly

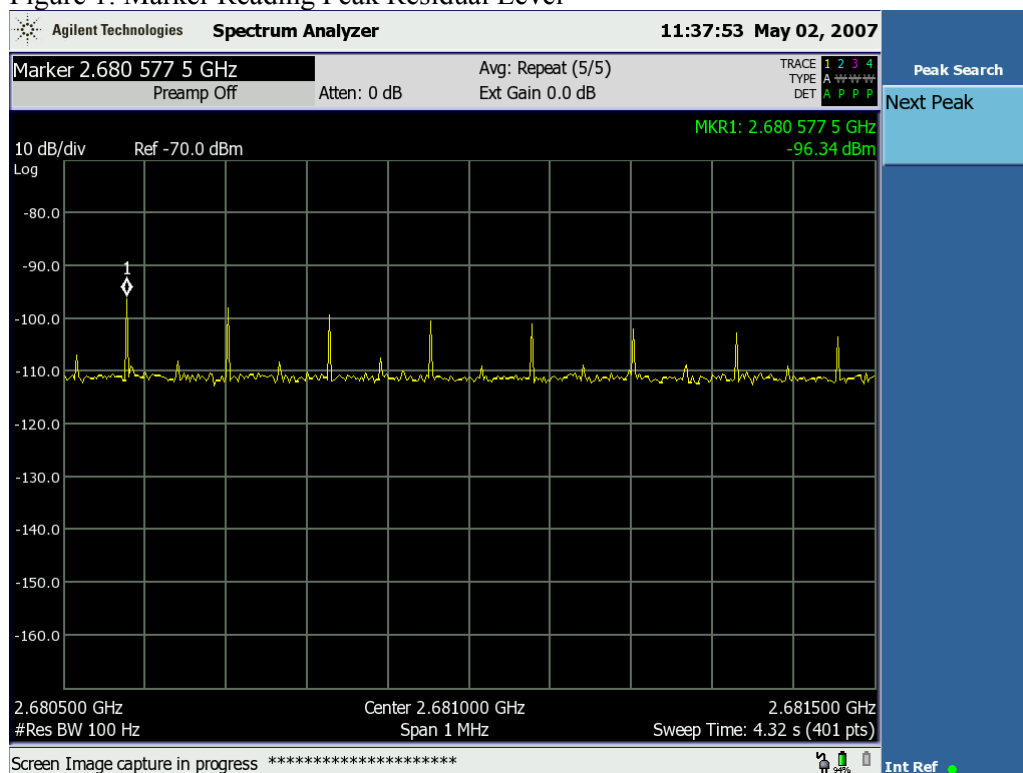
Figure 1: Marker Reading Peak Residual Level

1. Terminate the analyzer input with a 50 Ohm load.
2. Press **Mode, Spectrum Analyzer**.
3. Press **Mode Preset**.
4. Press **FREQ, Center Freq**, 2681 MHz
5. Press **SPAN**, 1 MHz
6. Press **AMPTD, Ref Level**, -70 dBm.
7. Press **BW, Res BW**, 100 Hz.
8. Press **Meas Setup, Avg Mode, Repeat**
9. Press **Avg Number**, 5, **Enter**
10. Press **Trace/Detector, Average**
11. Press **Single**. Wait until the message “Paused. Press Continuous or Single to Continue” appears on the status line at the bottom of the display.
12. Press **Peak Search**. The marker amplitude reading represents the level of the highest residual response. See Figure 1. Record this marker amplitude value in Table 1 in the Peak Residual Level column of the “As Received” row.

13. If the Peak Residual Level is above -97.7 dBm, the residual responses are too high. Proceed with Solution/Action.
