N1996A-01C

Agilent CSA Spectrum Analyzer, N1996A

Residual Responses due to Shield Problem on A4 Digital IF Assembly

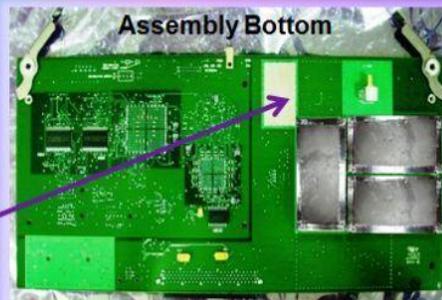
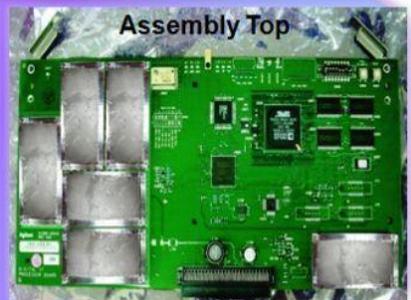
All the 9 large shield covers (5022-7816) on the DIF assembly are removed from the shield frame. The smaller shield cover (5022-2873) does not require any rework.
