T1250A-03

Modification Recommended Service Note

T1250A Smart RF Switching Unit

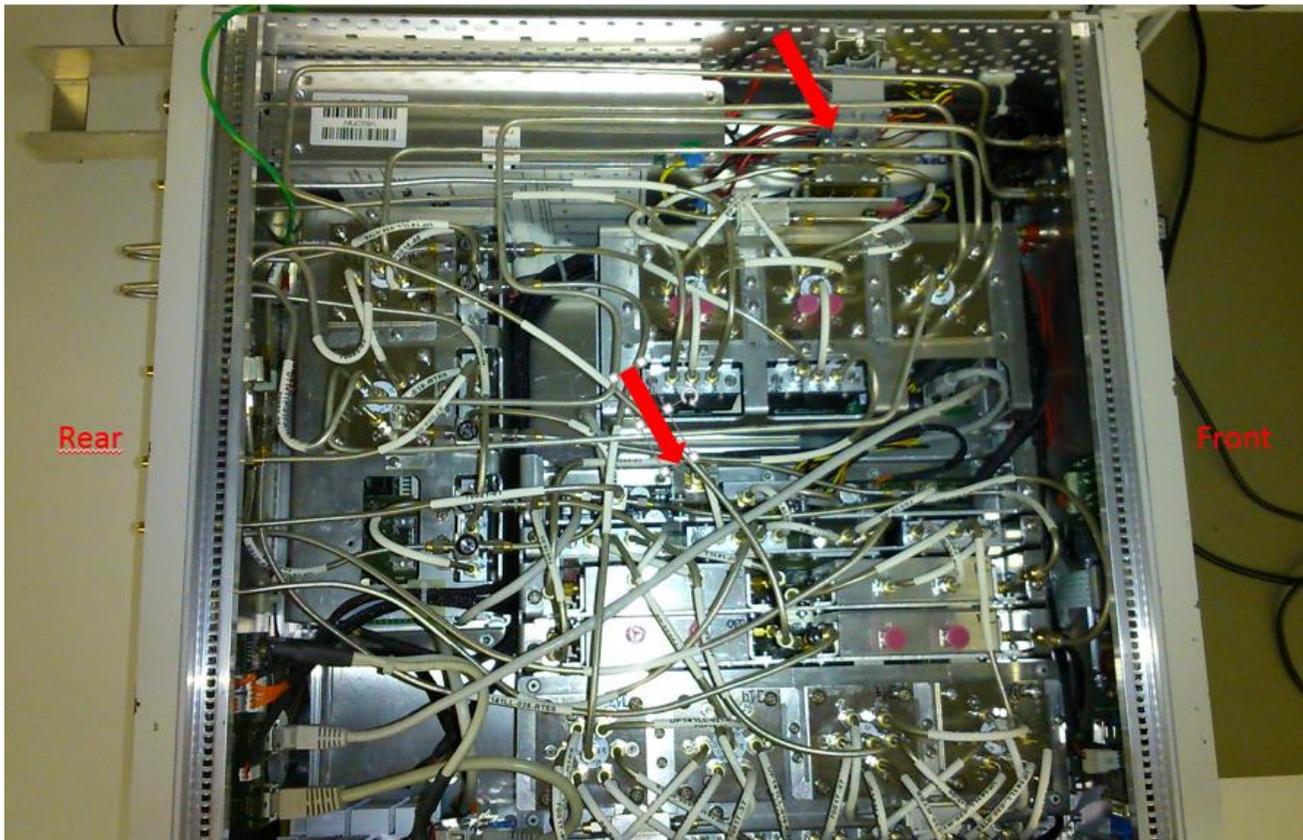
The following picture shows the YIG filters location:

Hot glue fix can be easily inspected by removing the top cover of the instrument, but the PCB inspection can only be done if the YIG module is disassembled.
