Modification Recommended Service Note

Keysight i3070 In-Circuit Test System Installed with XTPB Cards

New control XTPB card firmware to adjust the delay time for relay opening, to resolve intermittent relay failures observed on pin cards while working together with XTPB cards.

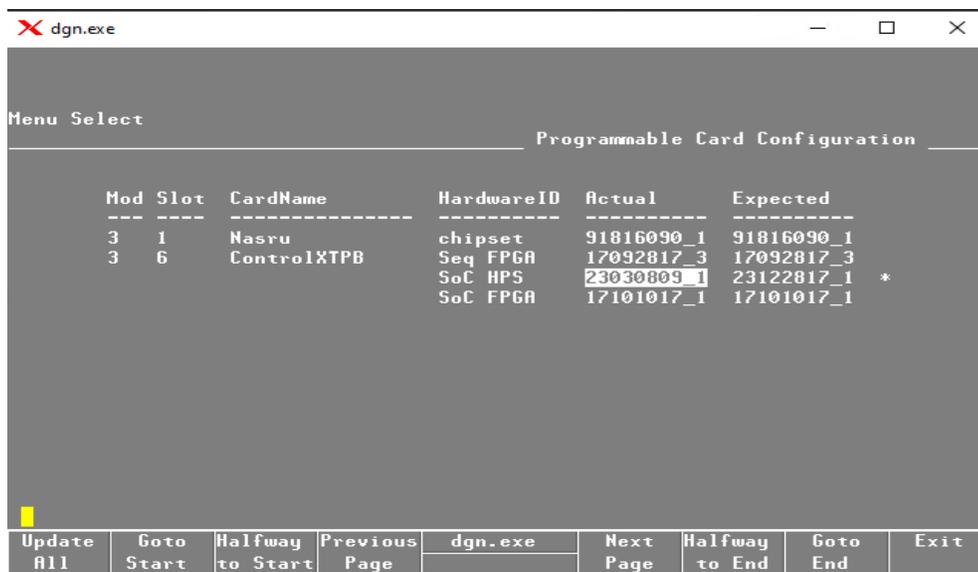
- 1. Download the latest firmware update file (XTPB_SoC_HPS_Mux.img) from [Keysight i3070 Control XTPB card firmware update | Keysight](#)
- 2. Copy the file to C:\i3070_ICT\lib folder in the i3070 system controller after renaming the original file there.
- 3. Launch DGN.
- 4. Select Configuration > Programmable Card Config.
- 5. Any available firmware updates will be highlighted as shown below:

6. Select Configuration > Programmable Card Config.
7. Select "Update All" to begin the update.
8. Whenever the User Account Control dialog box appears, select "Yes" to allow the system to proceed.
9. When installation is completed, reboot the testhead.
