86100D-11A

Modification Available Performance Enhancement Service Note

86100D Infiniium DCA-X Wide-Bandwidth Oscilloscope Mainframe

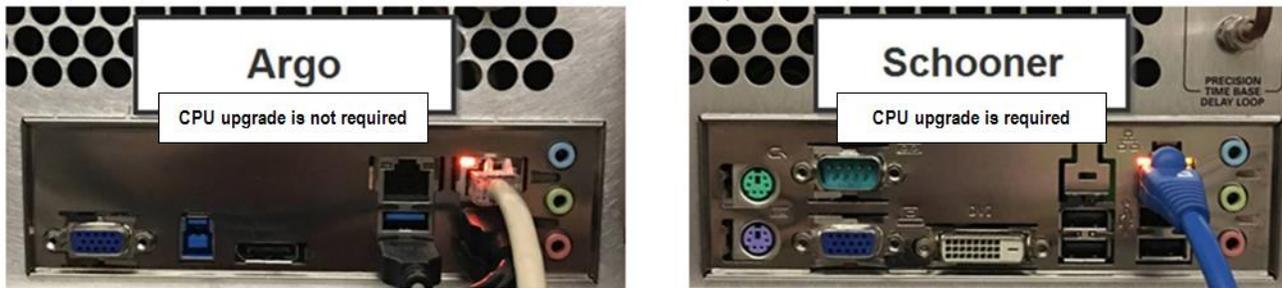
1. Serial Number:
 - a. SN \geq MY55400101 → Argo CPU. CPU upgrade is not required.
 - b. SN $<$ MY55400101 → May have either Argo or Schooner CPU. Further evaluation is required.
2. Visual. The connections available on the 86100D rear panel differ for the two CPUs:

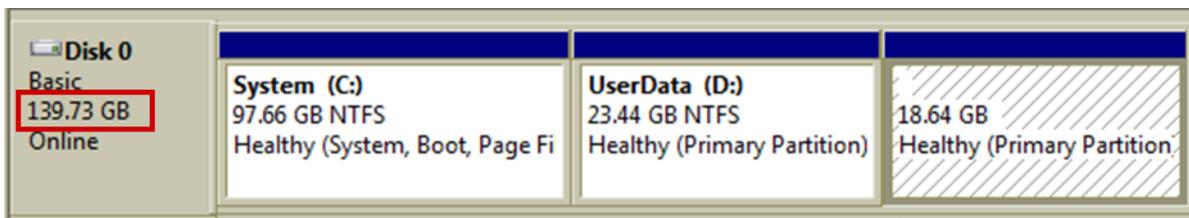
Open the Disk Management utility (Start > Run > compmgmt.msc > Storage > Disk Management) and note the total drive size (139.73 GB in the example below):

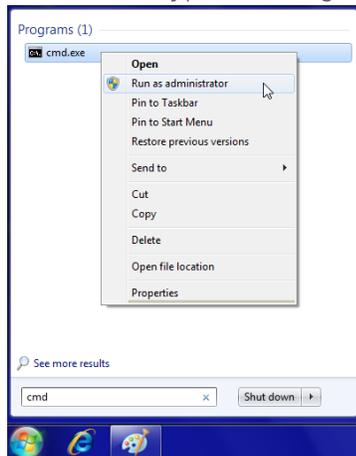
- a. Press **Start**, type **CMD**, right click on **CMD** and select **Run as Administrator**

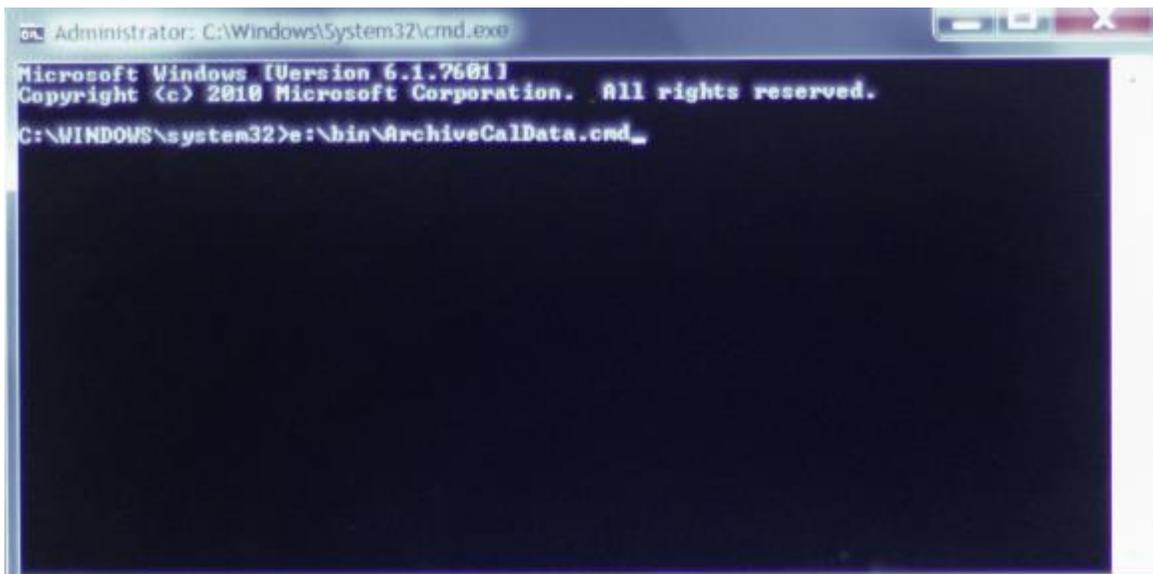
6. When the command prompt opens, run the command **e:\bin\ArchiveCalData.cmd**
 - a. Note that the drive assigned by Windows when the USB stick is inserted may be different than E:\. If so, use that drive letter instead of E:\

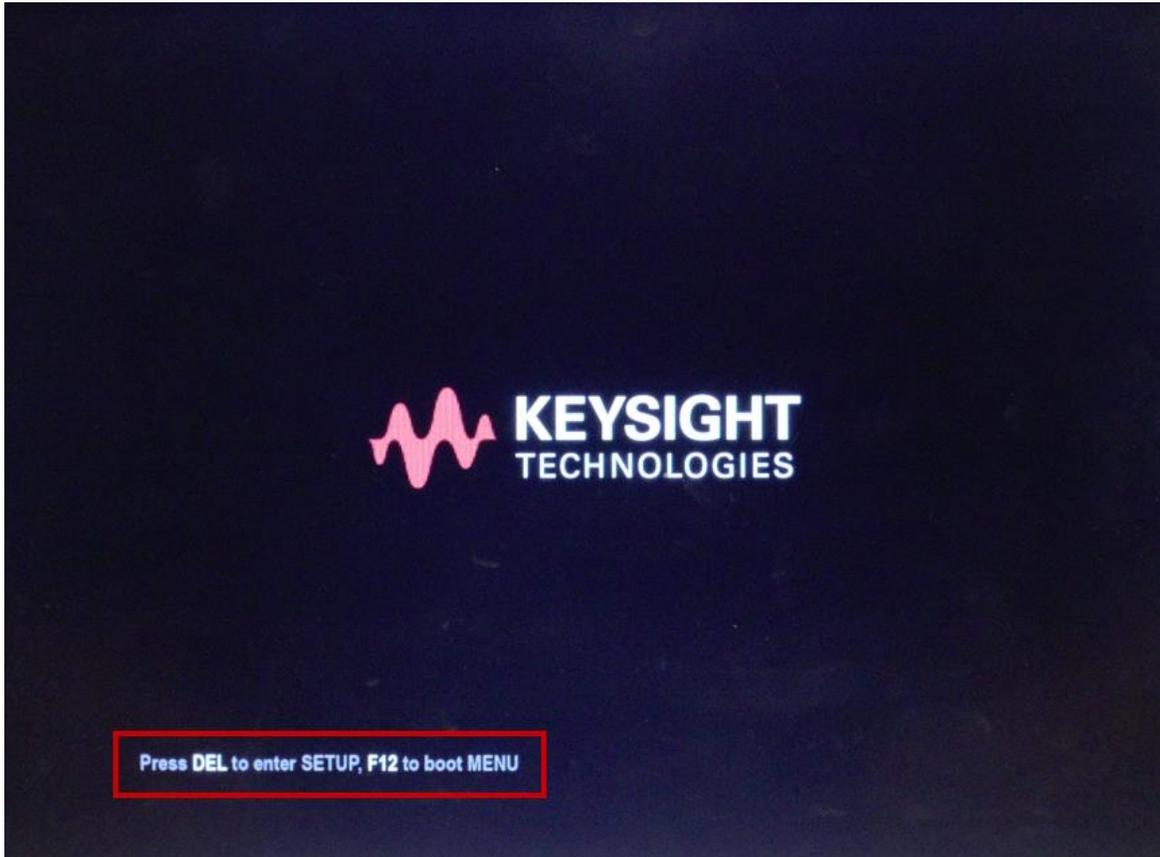
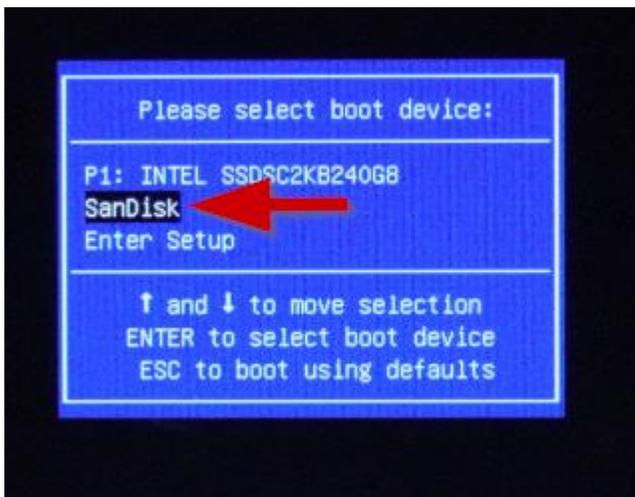
10. If the USB drive has been removed, re-insert it in a rear-panel port
11. Connect a USB keyboard and mouse to the instrument
12. Restart the instrument and boot from the USB drive:
 - a. Watch for prompt and press the F12 key
 - b. Select the USB drive in the Boot Menu (typically, "SanDisk")

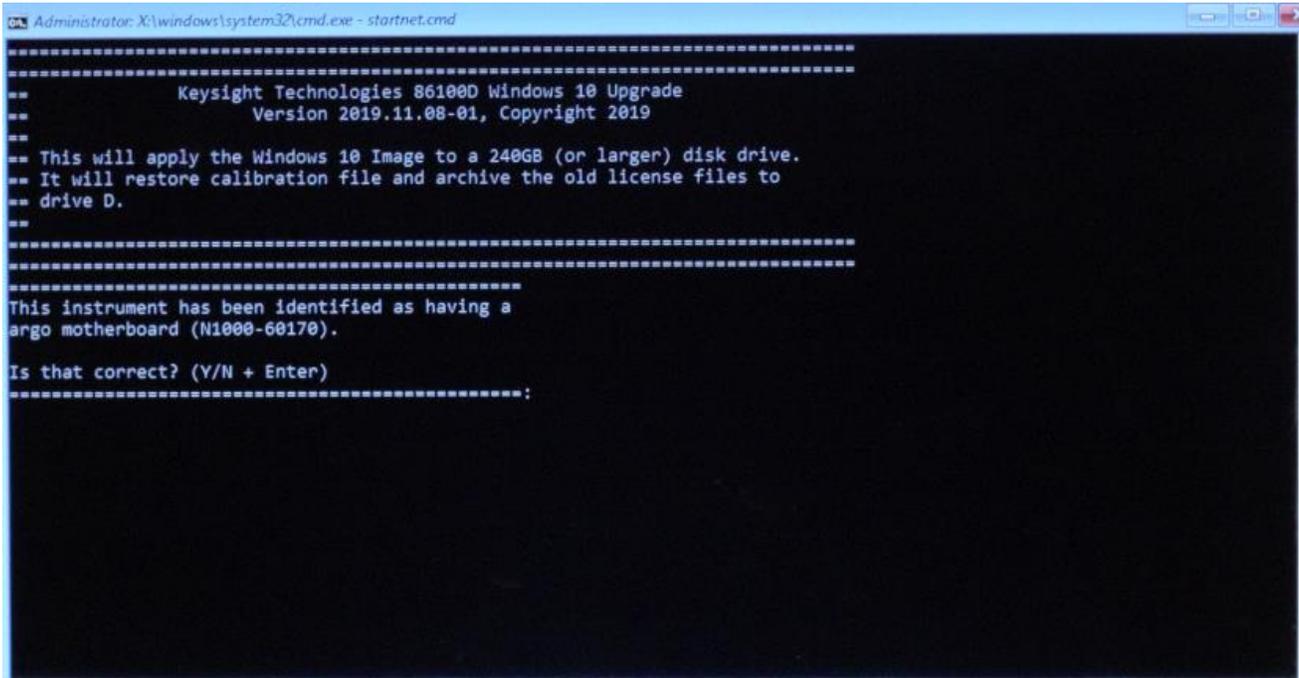
- 13. The CPU version is identified (it will take a few moments to get to this screen):
 - a. If a Schooner CPU is detected at this time, an error message will be displayed and the upgrade process will be aborted.

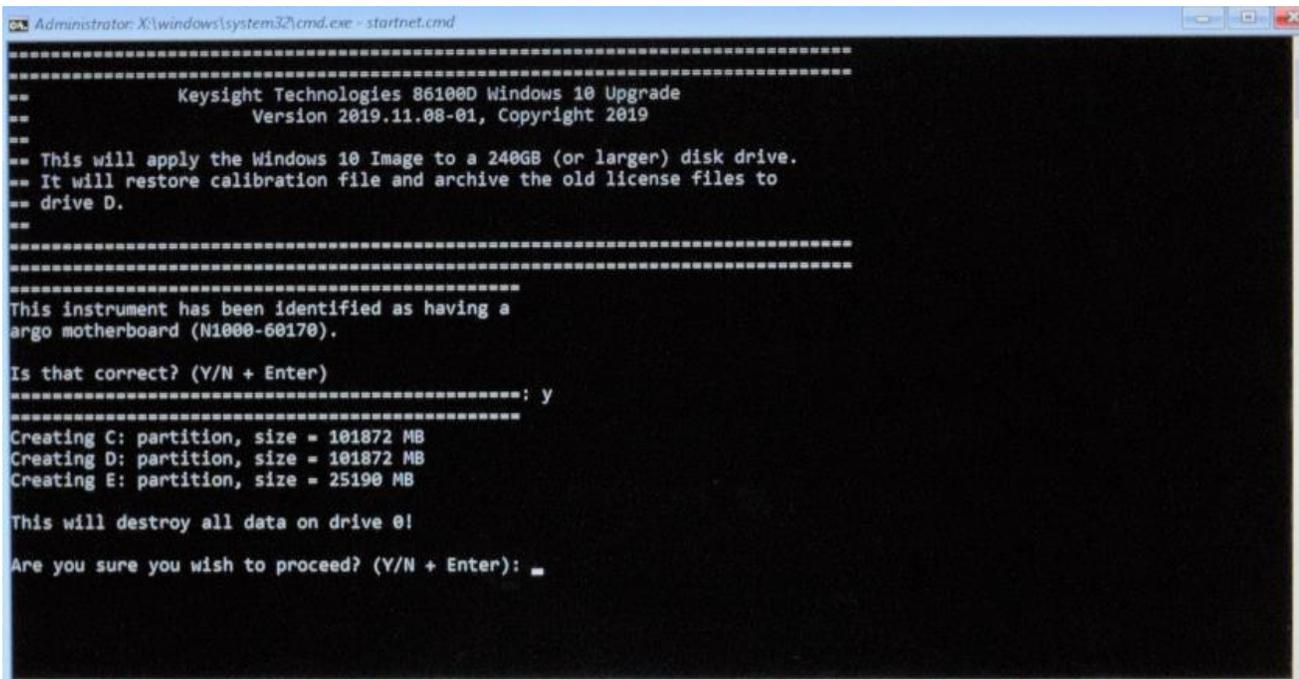
- 14. Partition size notification:
