# Modification Recommended Service Note

## Keysight i3070 Series 6 In-Circuit Test System

### The Problem:

New control XTPB card firmware to adjust the delay time for relay opening, to resolve intermittent relay failures observed on pin cards when working together with XTPB cards.

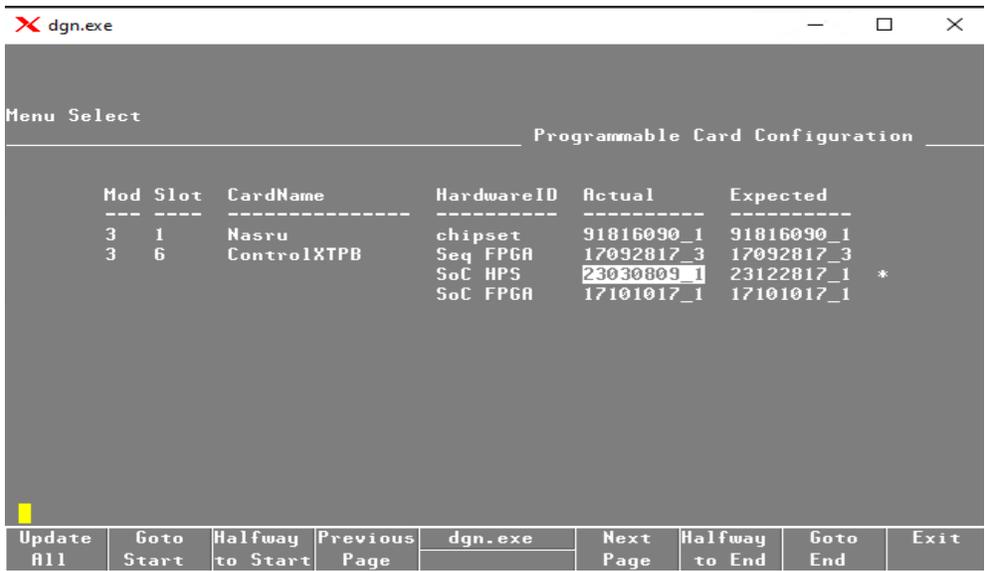
- 1. Download the latest firmware update file (XTPB\_SoC\_HPS\_Mux.img) from [Keysight i3070 Control XTPB card firmware update | Keysight](#)
- 2. Copy the file to C:\i3070\_ICT\lib folder in the i3070 system controller after renaming the original file there.
- 3. Launch DGN.
- 4. Select Configuration > Programmable Card Config.
- 5. Any available firmware updates will be highlighted as shown below:

6. Select Configuration > Programmable Card Config.
7. Select "Update All" to begin the update.
8. Whenever the User Account Control dialog box appears, select "Yes" to allow the system to proceed.
9. When installation is completed, reboot the testhead.
