N6841A Modification
on
Recommended
N6841A-01
High band
amplifier gain
could degrade

N6841A - RF Sensor

High band amplifier gain could degrade over time.

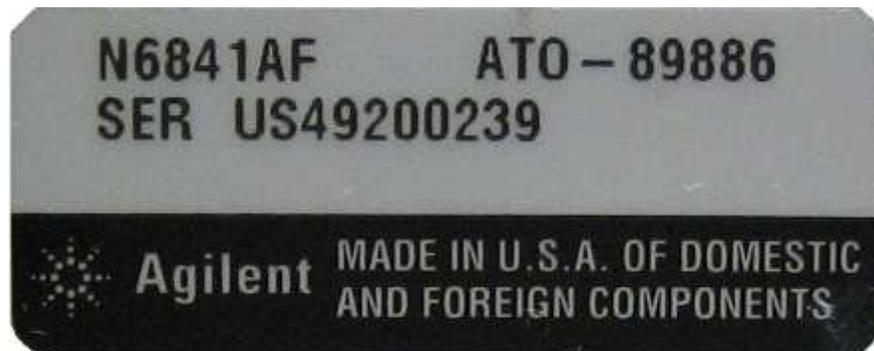
If your N6841A has the sticker shown below (**N6841AF** with your serial number) or has a serial number greater than US50310599, your N6841A has been upgraded.
