S E R V I C E N O T E

37718A Comms Performance Analyzer

Replacement of short semi-rigid mmxc links with more flexible type for improved reliability

DATE: August 2000

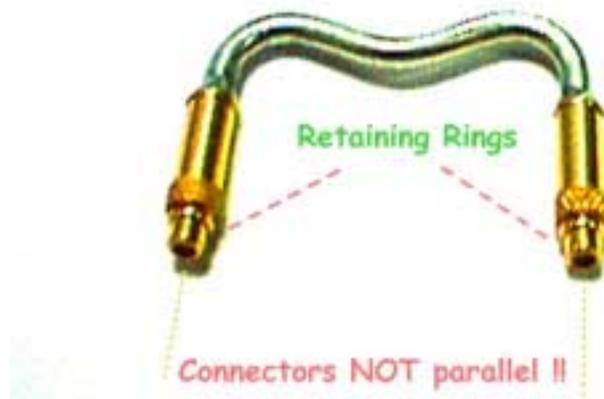
Examples of early and later type.

Figure 1 Early type semi-rigid short mmxc Module Interconnection Link

Figure 2 Later type semi-rigid short mmxc Module Interconnection Link

A more flexible, low profile type were introduced, reducing the stress on the connection retainers.

When any of the above units are in for service take the opportunity to check the type of link fitted and replace with the later type.

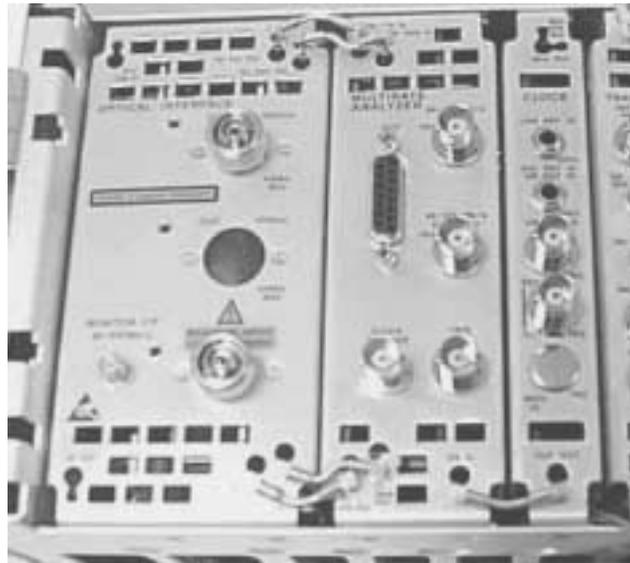
Figure 3. Forming 'C' and 'S' shapes.

2. Remove the early type short semi-rigid mmxc links and replace with the later type. To ensure the links do not obstruct the instrument cover, they should be carefully formed into the 'C' and 'S' shapes as shown below. Do not form/reform as this can weaken the link outer connection.

3. Ensure the new links 'CLICK' into position indicating that retaining clip has locked.
4. Refit the instrument cover as described in the 37718/19A Service Documentation - URL:
http://hpweb.sqf.hp.com/QTO_ProdSupp/hp37718_19a.htm
5. Run the Confidence Tests as described in the instrument Operation and Verification manual.
