70001A-20-S

S E R V I C E N O T E

**HP 70001A MMS Mainframe**

**Possible Fire Hazard**

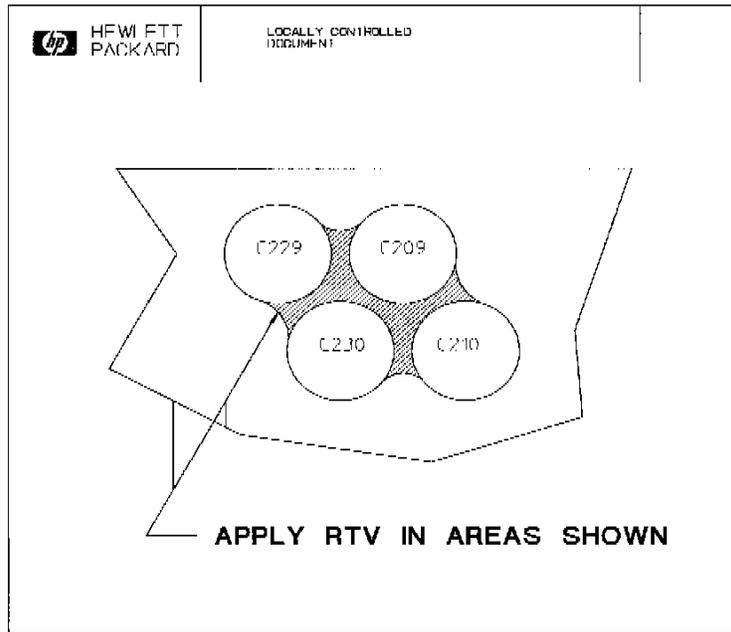
Replace the 4 power supply capacitors C209, C210, C229, and C230, part number 0180-4595, datecode 47Y01L33, with same part number, *any other datecode*. Use high power soldering iron ( $\geq 40W$ ) with tip temperature at 800 deg F. After removing capacitors clean board with water-based cleaning solution. After new capacitors have been installed, apply RTV between them for mechanical stabilization. (See attached diagram for RTV application process.)

The following notes give capacitor installation instructions and tests that **MUST** be performed following capacitor replacement.

1. Make sure that the caps are not installed backwards!! The stripe on the wrapper identifies the negative lead. All the caps should have their stripes facing the same way when properly installed.

2. The capacitor leads must be clipped after replacement to prevent them from working through the insulation and shorting to the housing. The clipped leads should protrude no more than 3/16 (0.180) inches in length.
