E3631A-12

S E R V I C E N O T E

E3631A DC Power Supply

±25V output channel displays intermittent conductivity to ground terminal

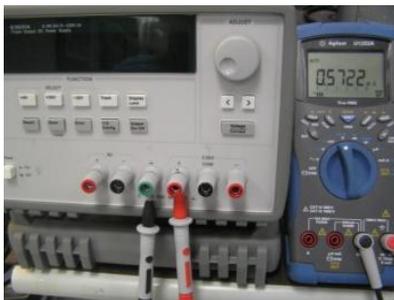
a) Use DMM to measure the impedance between:

b) If any of the measured impedance is below 1M ohm, the behavior described above is valid.

$+25\text{V}$ output power line to ground terminal

Customers with E3631A units displaying the behavior described above should contact their local Agilent Service Center and quote this service note number to arrange to have their instruments exchanged.

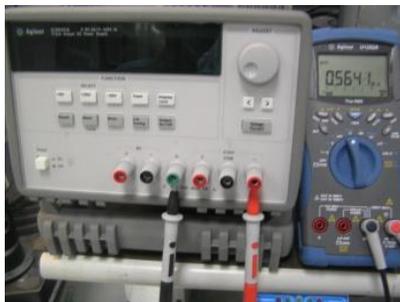
-25V output power line to ground terminal

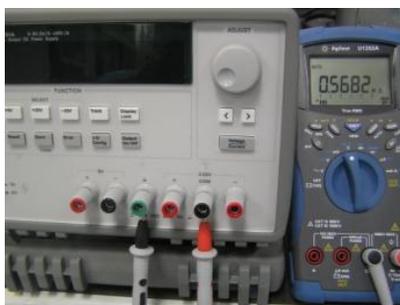
$\pm 25\text{V}$ output power line's common terminal to ground terminal
