E5052B-04**S E R V I C E N O T E**Supersedes:
NONE**E5052B Signal Source Analyzer****Serial Numbers: MY47201115 to MY47201421, SG47200134 to SG47200137****Automatically shut down after a few seconds beeping occurs when user turns on the instrument****Parts Required:**

Situation:

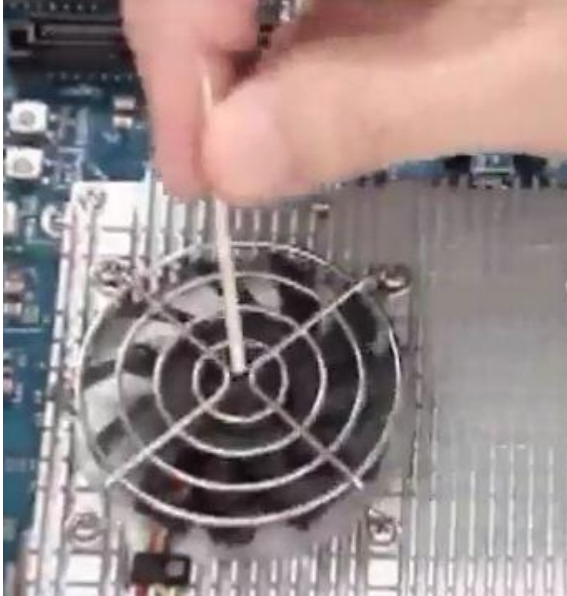
1. Push down CPU fan's rotor using something like tooth pick just after turning on power switch.

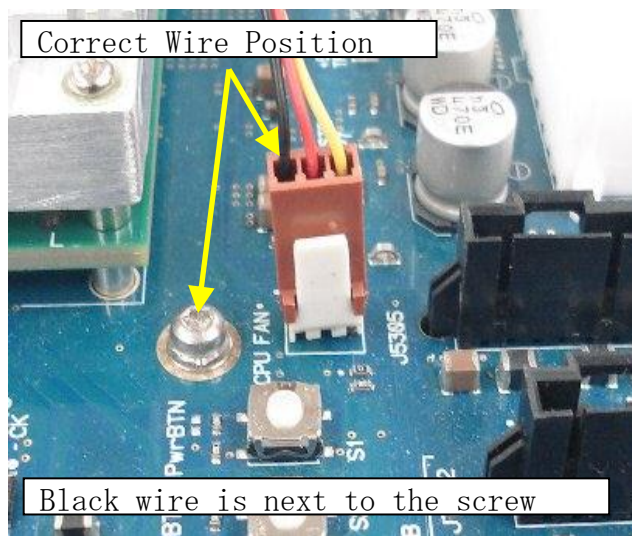
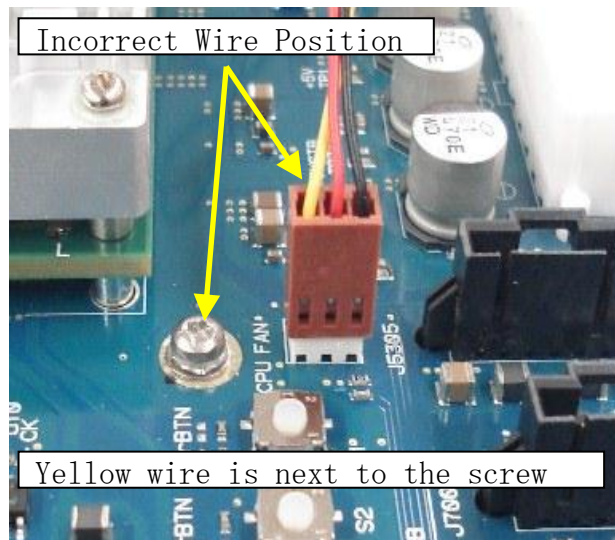
2-1. Check whether connector post (J19) for the CPU fan's interface cable is the correct direction or the opposite (incorrect) direction as shown below.

2-2. If black wire of the CPU fan cable is next to the nearby screw, J19 is assembled in a correct way. In this case, just replace CPU fan with a new one (3160-4452) for repair.

2-3. If yellow wire of the CPU fan cable is next to the nearby screw, J19 is assembled in an incorrect way. In this case, disconnect the CPU fan cable from J19 and measure CPLD voltage of the pin
