S E R V I C E N O T E

**E5515A,B,T Wireless Communications Test Set (8960 Series 10)**

**Incorrect Output Levels Requires Replacement of RTI EEPROMs**

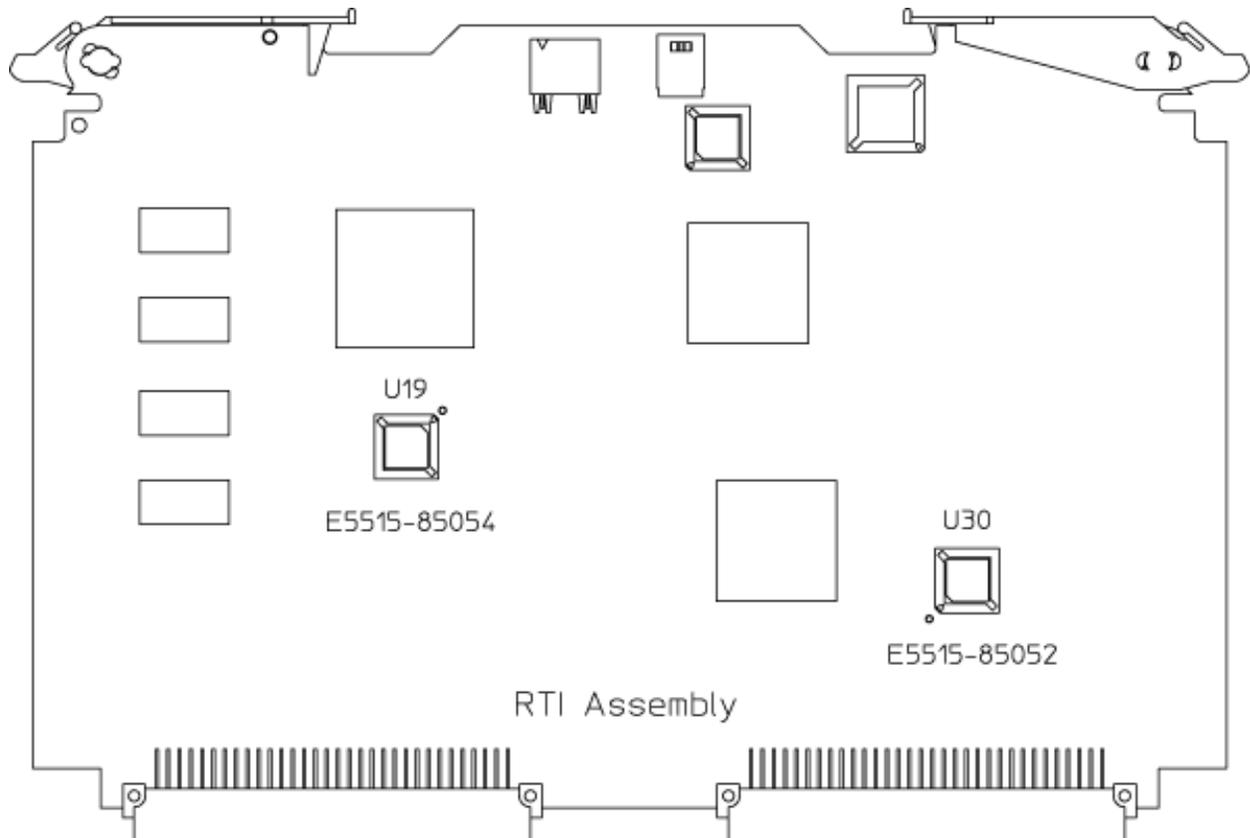
The RTI (Real Time Interface) is used to setup and maintain control between the Test Set and cellular phone (mobile-station-under-test). The RTI assembly requires replacement of two EEPROMs (U19 and U30) to correct intermittent and incorrect source output levels and/or instrument lock-up. Re-cycling power may temporarily restore correct operation; EEPROM replacement is recommended.

Replace U19 and U30 (refer to Figure 1). Use the proper anti-static protection and PLCC extraction tool (refer to Newark.com catalog part numbers 92N4239 or 46N6568) to remove and replace these EEPROMs. The EEPROMs are labeled with reference designators 'U19' and 'U30'. Do not use these labels for EEPROM orientation. Insure that the EEPROMs are correctly aligned (from EEPROM notch or cut-corner to the locator dot on Figure 1).
