**SN J6800A-05**

# S E R V I C E                      N O T E

## J6800A Analyzer

**If it is necessary to replace the CDROM drive in the J6800A a special tool is required to properly align the CDROM drive in the mounting bracket.**

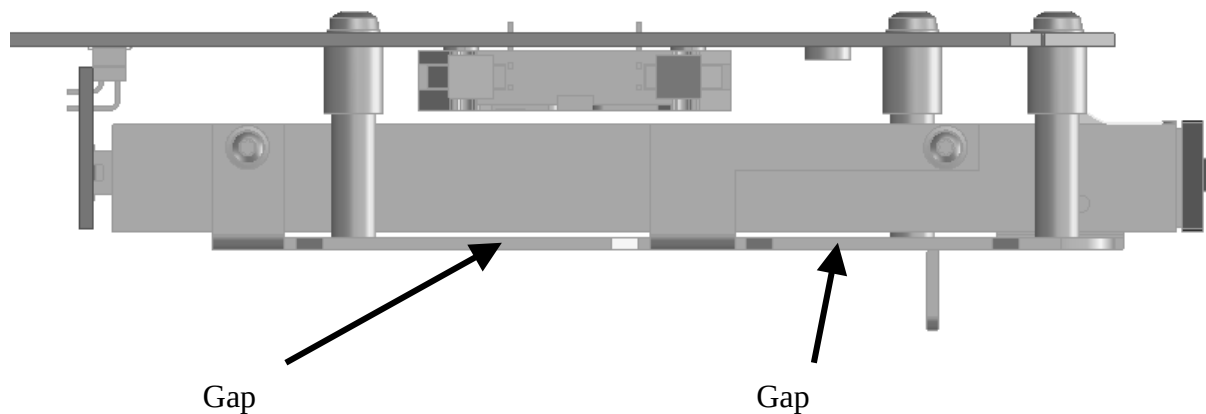
To assure proper positioning of the CD-RW drive onto the bracket is to make a flat, 0.8 mm thick tool (T-308355) which is laid onto the surface of the sheet-metal against which the drive is mounted. Then, place the drive onto the bracket sandwiching the tool between the drive and the bracket. Assure that the drive is resting in contact with the tool. Then install the four M2 screws holding the drive onto the bracket. Then, slide the tool out, which should leave a 0.8 mm gap between the underside of the drive and the bracket. You can see this small gap between the bracket and the drive in the picture below. .
