**SN J6802B-03**

**S E R V I C E N O T E**

**J6802B DNA MX Analyzer**

After replacing the SBC (0960-2446) in the J6802B the system BIOS needs to be updated prior to testing and verification.

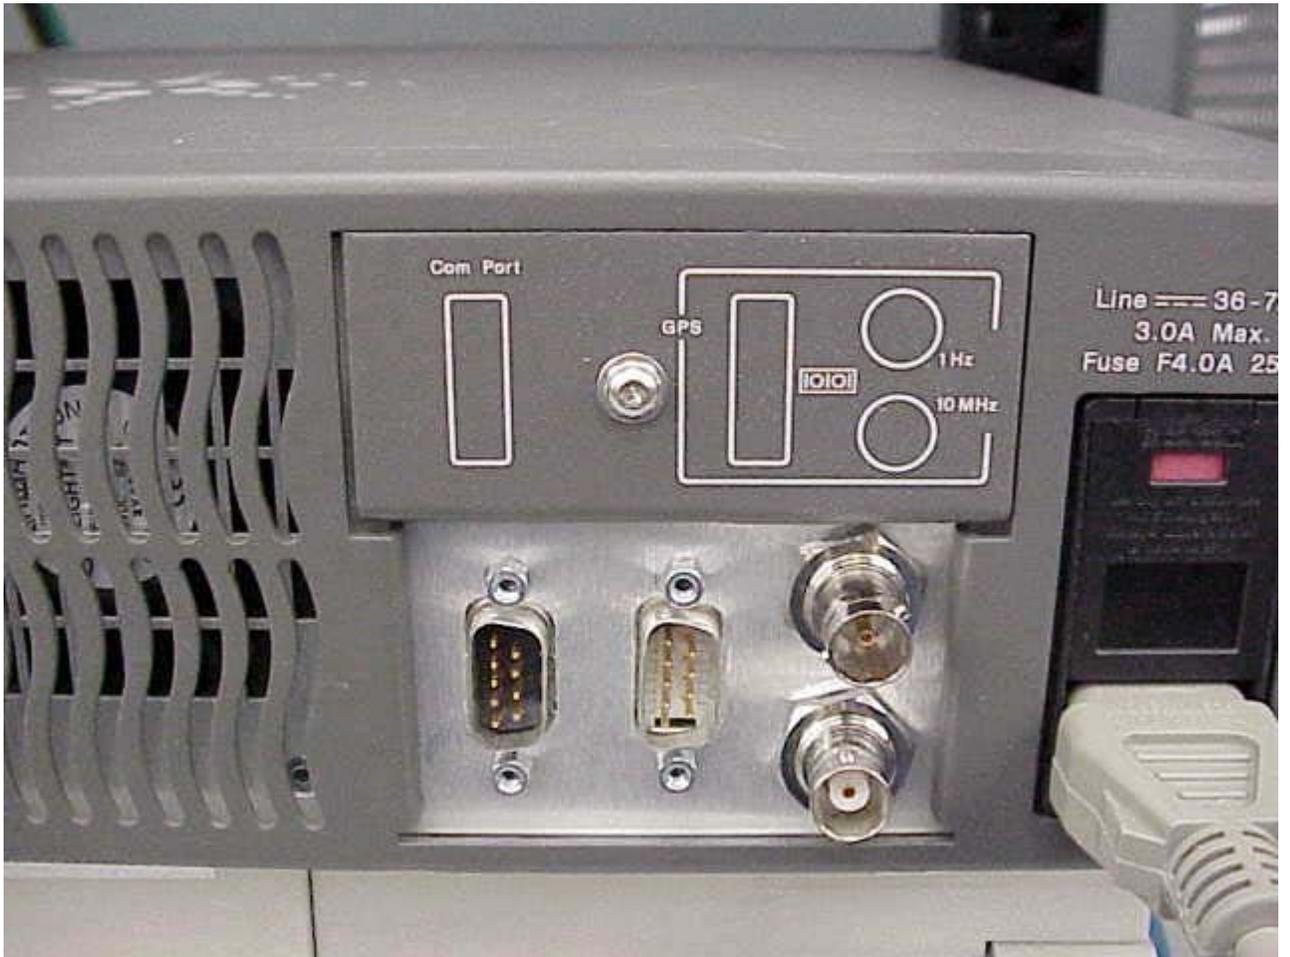
#2 Attach a VGA monitor and PS2 keyboard to the connectors on the rear of the instrument. (Note: The connectors are behind the small “door”. See photo )
