N5173B-06

Information Only Service Note

N5173B X-Series EXG μ Wave Analog Signal Generator

The Problem – Potential for Damage Caused by Hipot Safety Testing

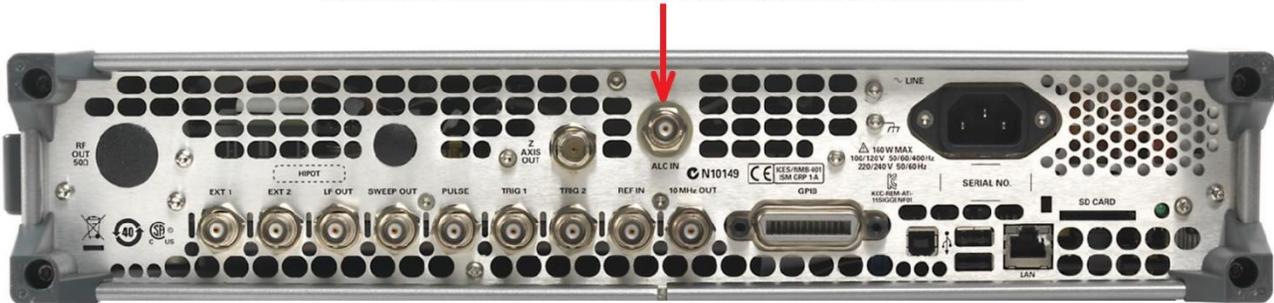
It has come to our attention that instruments have been damaged using a Hipot tester when performing incoming and outgoing safety testing on these instruments. These safety testers require that a ground wire from the tester be connected to the instrument chassis. This connection is often made to the outer conductor of one of the rear panel BNC connectors. The problem occurs when the ground wire is connected to the ALC IN rear panel BNC connector outer conductor when the test is run. Connecting the ground to this point is a problem because the ALC IN connector outer conductor is not connected to the chassis of the instrument. It is isolated from the chassis ground with a plastic washer. Not only is this an invalid point to connect the ground wire to for this test, it also sends the high voltage level directly into the sensitive ALC input circuitry.

DO NOT Connect Ground Wire to ALC IN Connector

The typical failure symptoms of an instrument that has been exposed to this is the failure of Self Tests 407, 1107, 1108, 1112 (some or all of these). The parts that will be damaged are on the A7A1 Microwave ALC Control board, so the power level accuracy test will most likely fail as well.

Do not connect the Hipot safety tester ground wire to the ALC IN connector shield.

It is also recommended that a static safe protective cap be put on the ALC IN connector before it is given to your logistics team so that nobody will be able to easily connect the ground wire to it when they perform a safety test. This will also help to protect it if it goes through an incoming inspection safety test once it has reached its destination.
